Comhairle Ceantair
Lár Uladh
Mid Ulster
District Council

COTT LANE FOOTBRIDGE
PRINCIPAL INSPECTION REPORT

Project No	Revision	Prepared by	Checked by	Approved by	Status	Date
16/140C	1	PDD	TS	TS	FINAL	24/10/2016

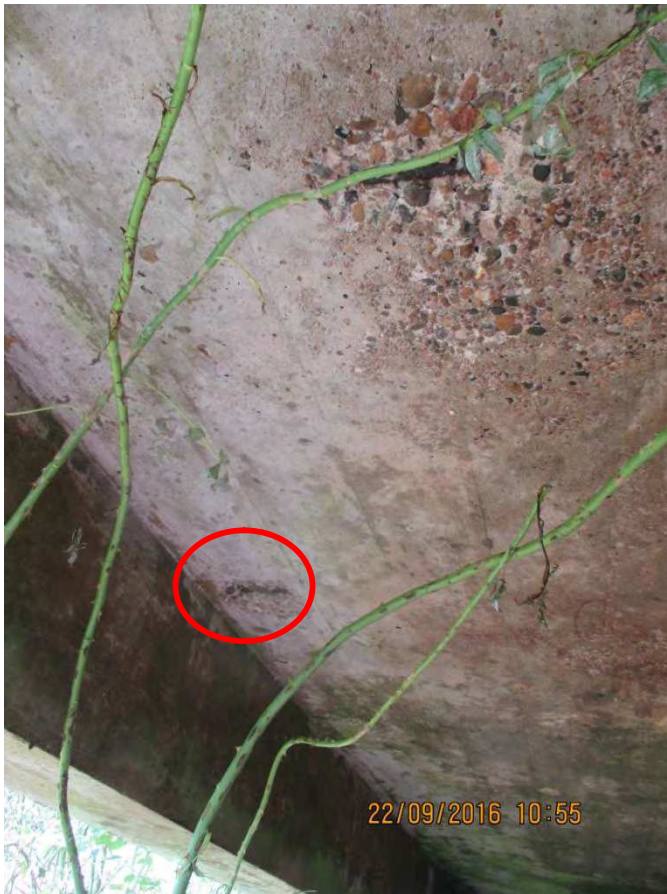
Photograph 9: Span 1- Item 2.

1. Slight water ingress was noted at one location. There are other locations where water staining is visible.
2. 3.2m from Abutment 1 (Photograph No. 9)- Concrete spalling; area approx. 80x80x20mm deep. One reinforcing bar is exposed; corrosion is visible with slight loss of section.
3. 3.9m from abutment 1(Photograph No. 10)- Concrete spalling; area approx. 100x50x20mm deep. One reinforcing bar is exposed; corrosion is visible with minimal loss of section.
4. At Pier No.1- area approx. 200x90x20mm deep (Photograph No. 11). One reinforcing bar is exposed; corrosion is visible with significant loss of section.
5. There is minor concrete damage on the edge of the deck slab at 2 No. locations on the downstream face, see Photograph No's 12 & 13, one reinforcing bar is exposed at each location with minor corrosion visible.

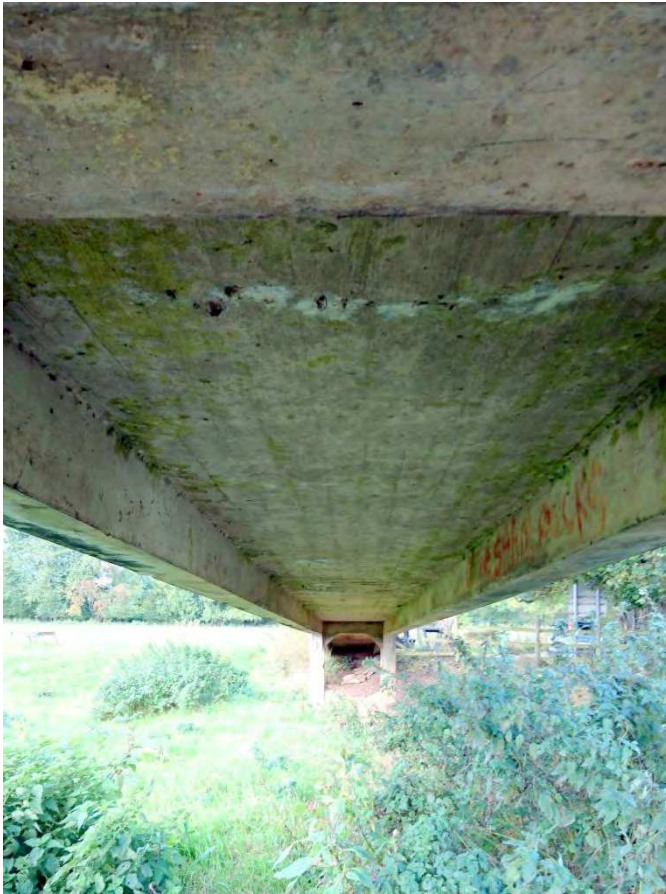
Photograph 17: Span 2- Deck overview

5. 10.8m from Pier 1(Photograph No. 22)- Water seepage is evident on deck at this location. Other isolated evidence of water seepage are visible.
6. Seepage appears to follow the line of a hairline crack approx. 0.5m from Pier 2- See Photograph No. 17.

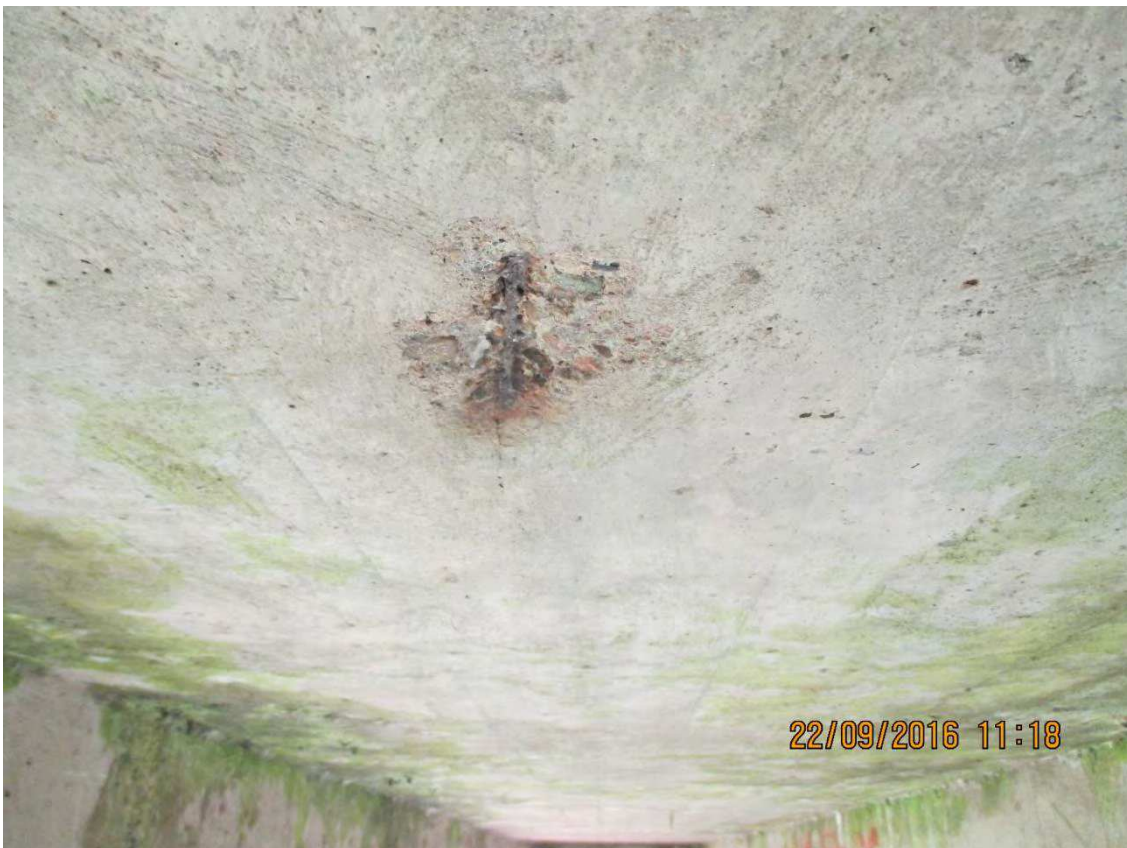
Photograph 18: Span 2- Item 1

1. 7.3m from Pier 1 (Photograph No. 18)- Concrete spalling; area approx. 120x40x15mm deep. One reinforcing bar is exposed; corrosion is visible with minimal loss of section.

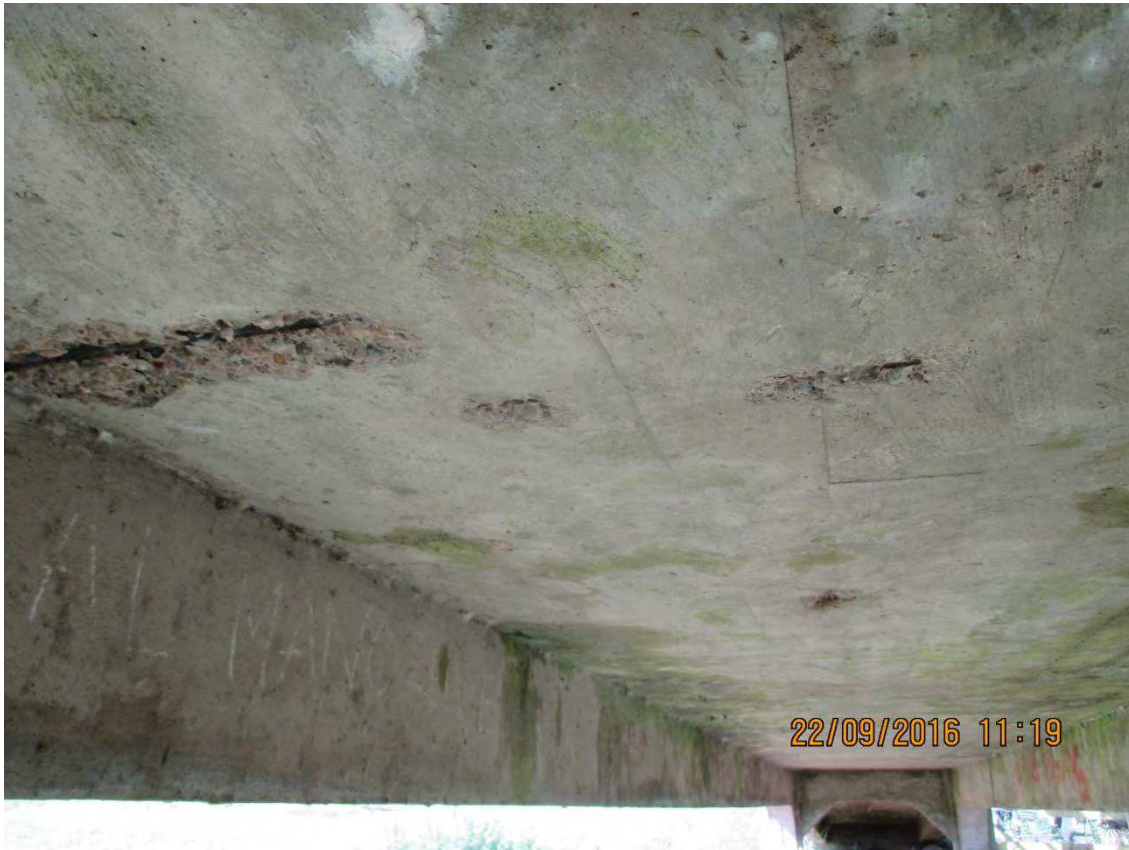
Photograph 19: Span 2- Item 2

2. 8.3m from Pier 1 (Photograph No. 19)- Concrete spalling; 3 areas approx. 260x80x15mm deep and 2 No. at 50x50x15mm deep. One reinforcing bar is exposed at each location; corrosion is visible with loss of section.

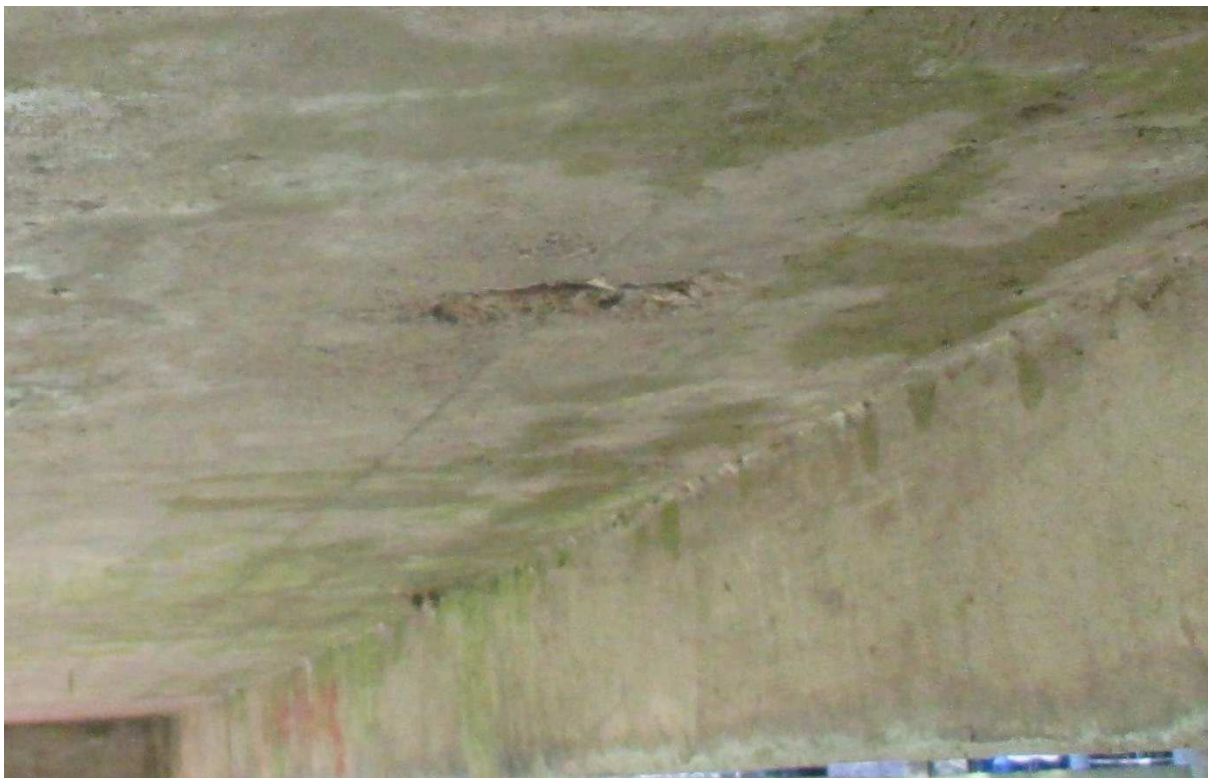
Photograph 20: Span 2- Item 3.

3. 8.6m from Pier 1(Photograph No. 20)- Concrete spalling; area approx. 200x100x15mm deep. One reinforcing bar is exposed; corrosion is visible with loss of section.

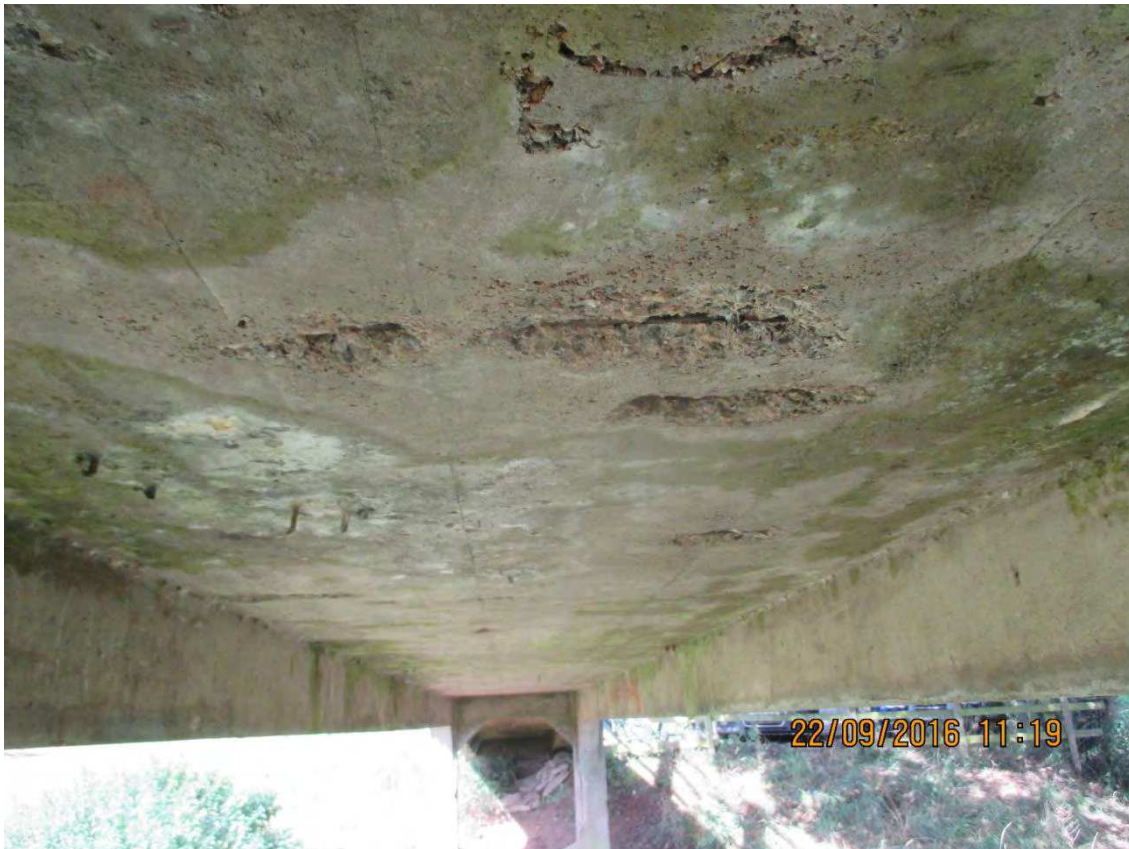
Photograph 21: Span 2- Item 4.

4. 9.2m from Pier 1(Photograph No. 21) - Concrete spalling; 3 locations within an area of approx. 400x200mm. One reinforcing bar is exposed at each location; corrosion is visible with loss of section.

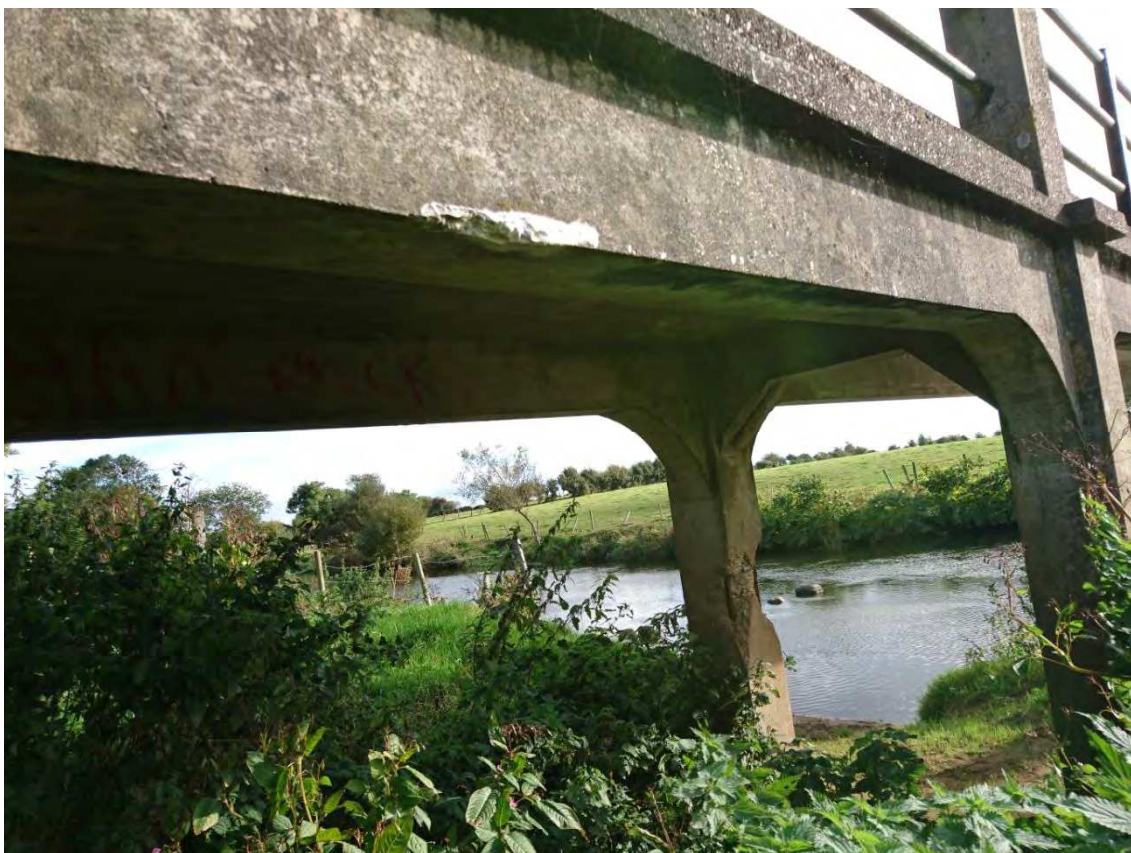
Photograph 24: Span 2- U/S Edge Beam- Item 1.

- Upstream Beam (Photograph No. 23):
 1. 13.0m from Pier 1(Photograph No. 24) 0112- Minor concrete damage at bottom of beam approx. 200x20x15mm deep.
- Downstream Beam (Photograph No. 25):
 1. Water staining visible at 2 locations on beam.

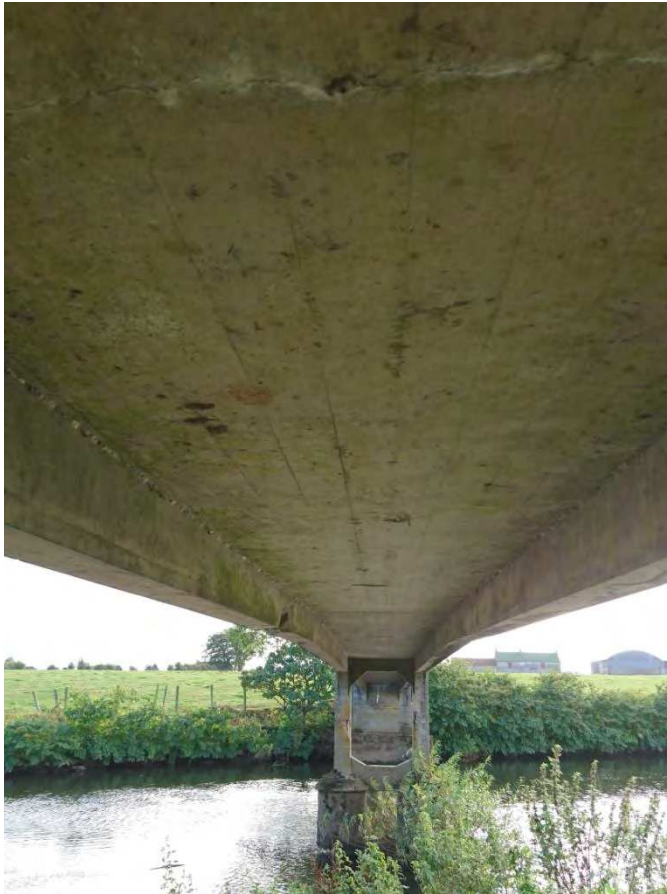
Photograph 27: Span 3- Deck overview

2. 4.9m from Pier 2 (Photograph No. 29)- Concrete spalling; 2 areas approx. 200x100x10mm deep and 300x25x10mm deep. One reinforcing bar is exposed; corrosion is visible at each location with minor loss of section.
3. 9.0m from Pier 1(Photograph No. 30)- Concrete spalling; area approx. 200x100x15mm deep. One reinforcing bar is exposed; corrosion is visible with loss of section.
4. (Photograph No. 31)- Concrete spalling; 3 isolated locations at approx. 9.0m, 10.0m and 13.0m from Pier 2. One reinforcing bar is exposed at each location; corrosion is visible.
5. Seepage appears to follow the line of a hairline crack approx. 0.5m from Pier 2- See Photograph No. 27.

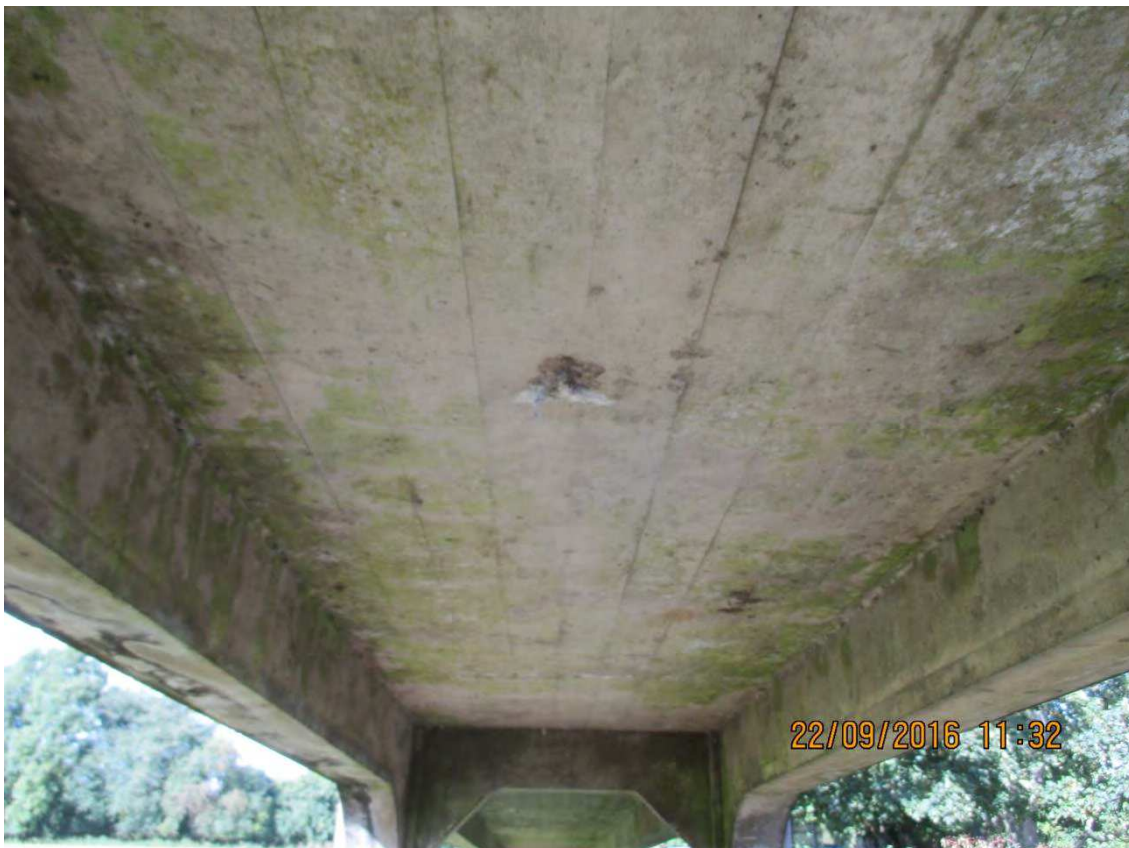
Photograph 28: Span 3- Item 1.

1. 2.9m from Pier 2 (Photograph No. 28)- Concrete spalling; area approx. 70x70x10mm deep. One reinforcing bar is exposed; corrosion is visible with significant loss of section.

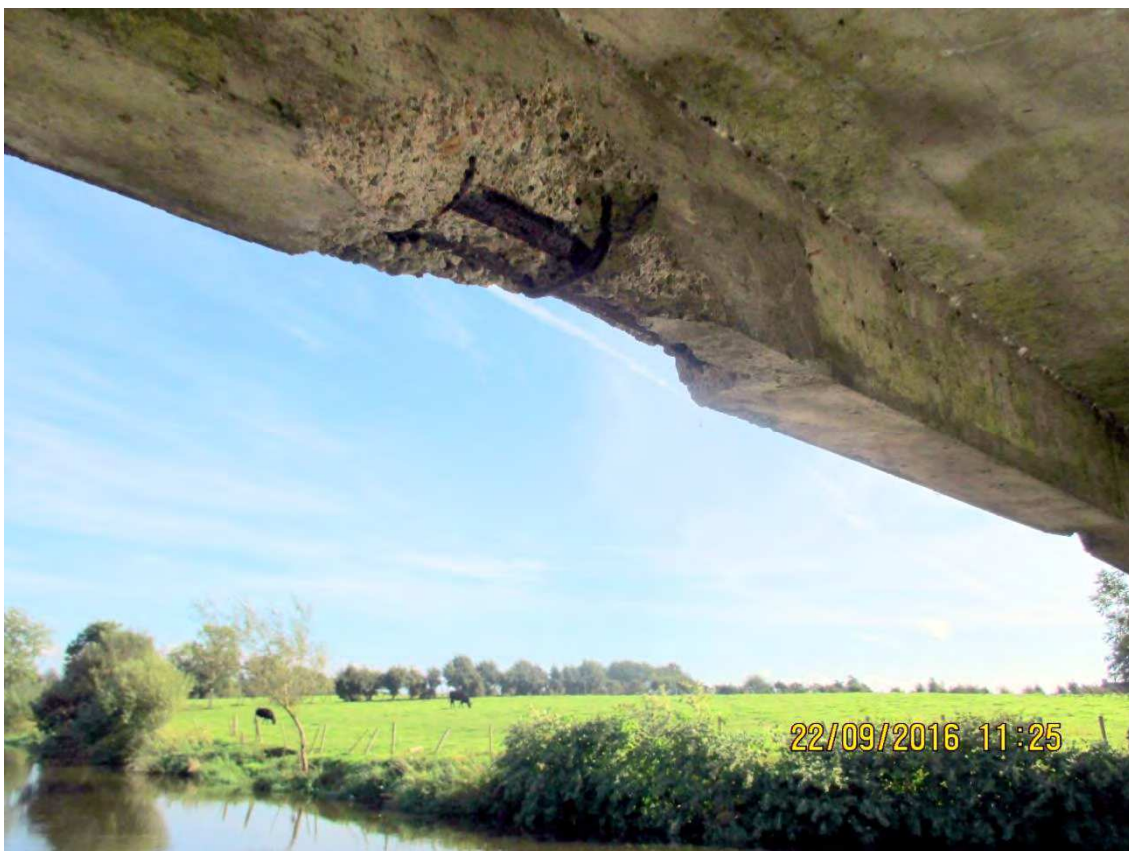
Photograph 34: Span 3- D/S Edge Beam- Item 1.

- Upstream Beam (Photograph No. 32):
 1. No significant damage identified.
- Downstream Beam (Photograph 33):
 1. 5.7m from Pier 2 (Photograph No. 34)- Significant concrete spalling/ damage; area of approx. 600 long x 200x50-70mm deep. Two reinforcing bars are exposed; corrosion is visible with loss of section.
 2. 7.2m from Pier 2 (Photograph No. 35)- Concrete spalling; area of approx. 300mm long x200x50mm deep. One reinforcing bar is exposed; corrosion is visible with loss of section.

- 5.3 The edge beams exhibit signs of generally isolated concrete spalling and subsequent corrosion of reinforcement at these locations. There is however significant damage to the downstream edge beam between Piers 2 and 3. Vertical hairline cracking was also identified on beams between Pier 3 and Abutment 2.

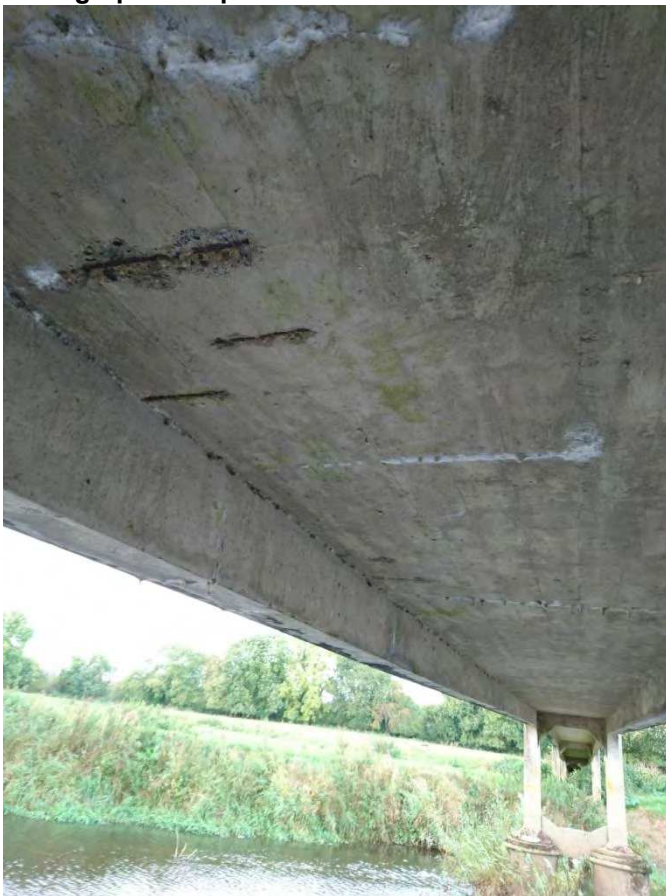
Photograph 38: Span 4- Item 1.

1. 1.2m from Pier 4 (Photograph No. 38)- Concrete spalling; 3 areas approx. 200x40x10mm deep and 2 No. 100x40x10mm deep. One reinforcing bar is exposed; corrosion is visible with loss of section.
2. Isolated area of water seepage/ leakage visible. There are two areas where seepage appears to have occurred along a hairline crack in the deck at approx. 0.5m from Pier 4 and at mid span (see Photograph No. 38).

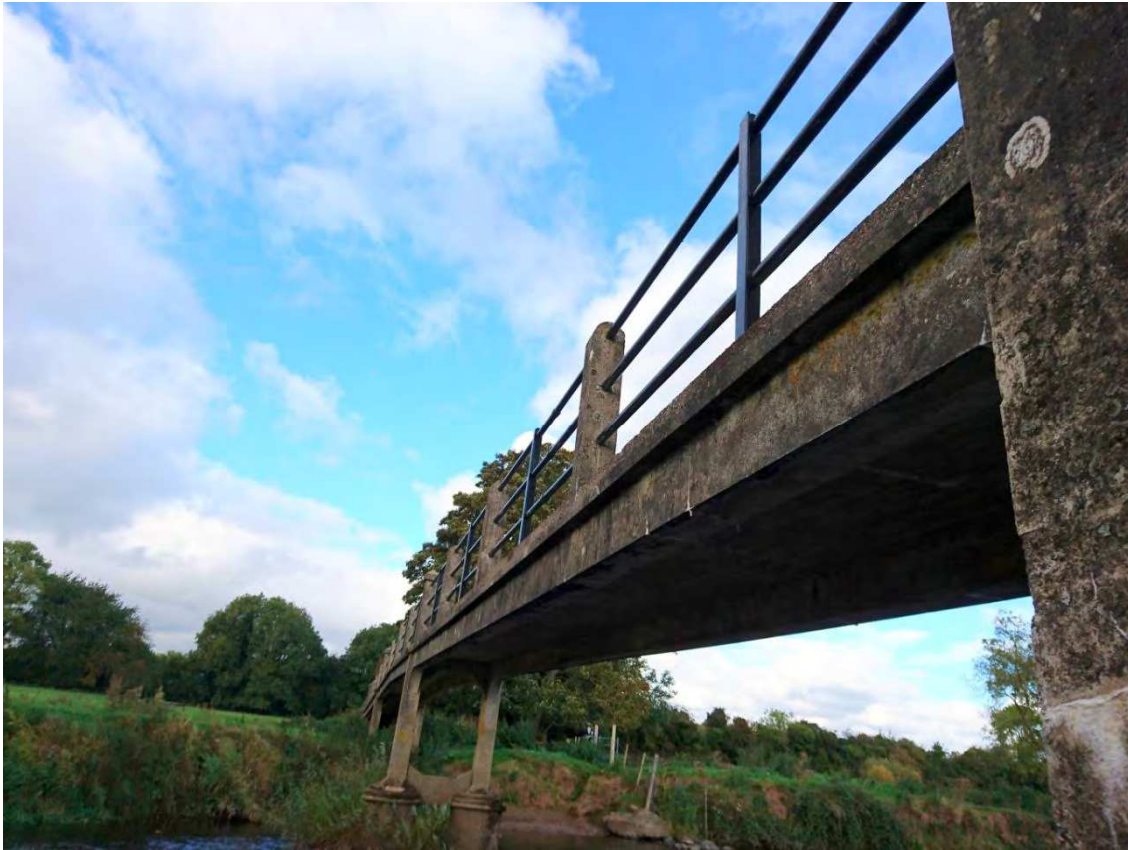
Photograph 39: Span 4- U/S Edge Beam.

- Upstream Beam (Photograph No. 39):
 1. Vertical hairline cracks are visible along the beam.

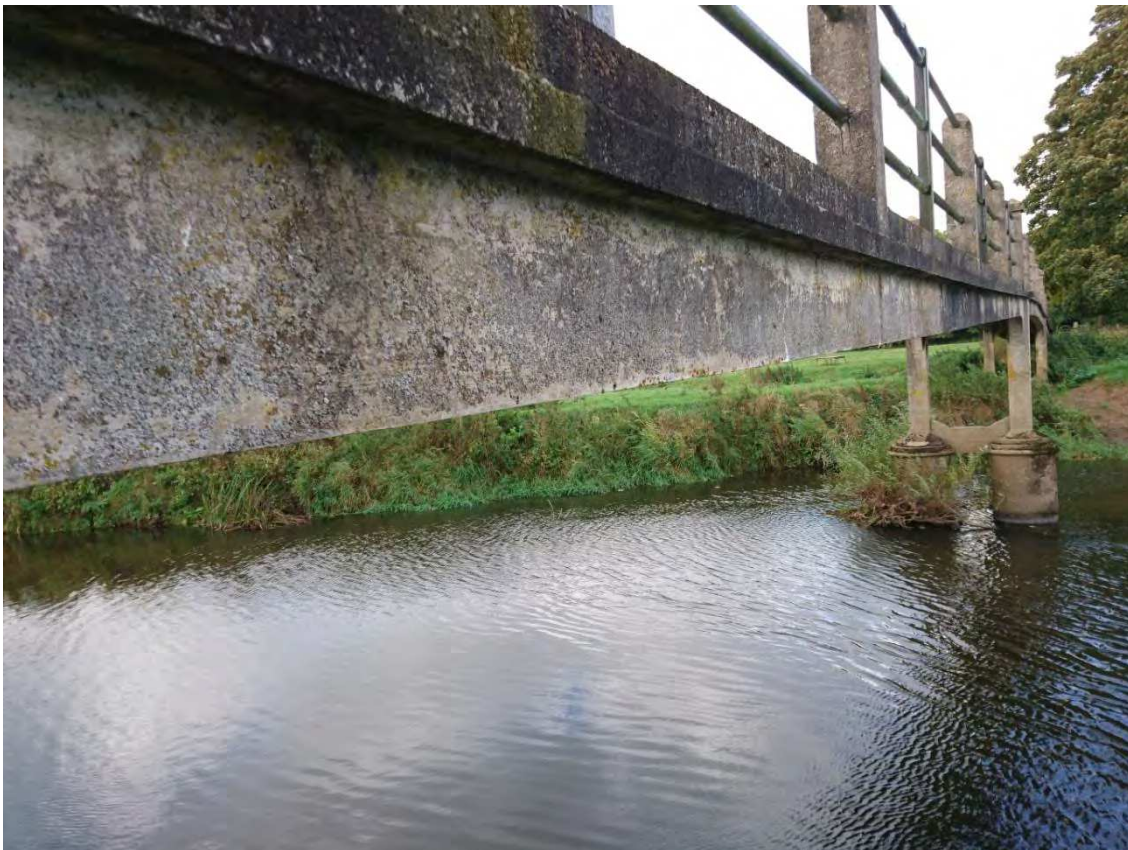
Photograph 40: Span 4- D/S Edge Beam.

- Downstream Beam (Photograph 40):
 1. 4.0m & 7.0m from Pier 4 (Photograph No. 41)- Concrete spalling; 2 isolated areas. One reinforcing bar exposed; corrosion is visible with loss of section.
 2. Vertical hairline cracks are visible along the beam.

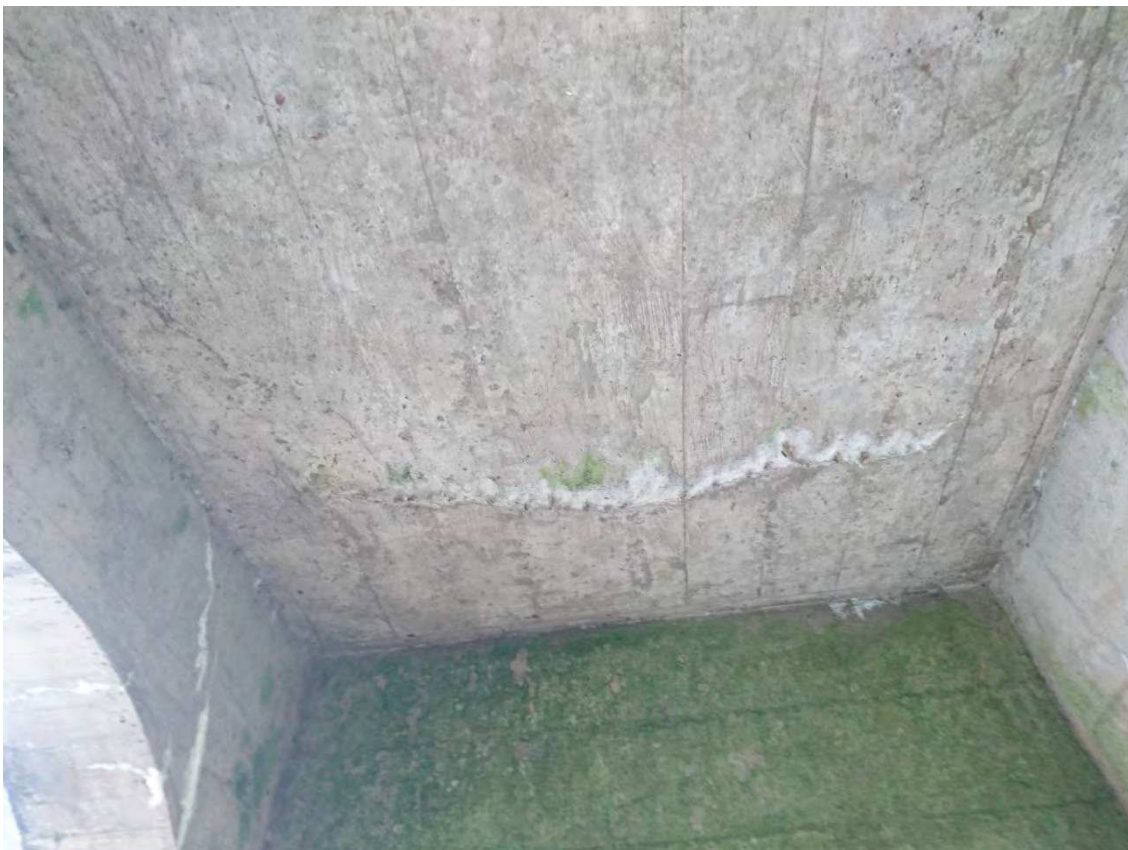
Photograph 44: Span 5- Item 1.

1. A hairline crack is visible approx. 0.5m from pier 4 (see Photograph No. 44) with evidence of seepage/ leachate from the crack. This crack continues down into the edge beams.
2. Isolated areas of water seepage/ leakage are visible.

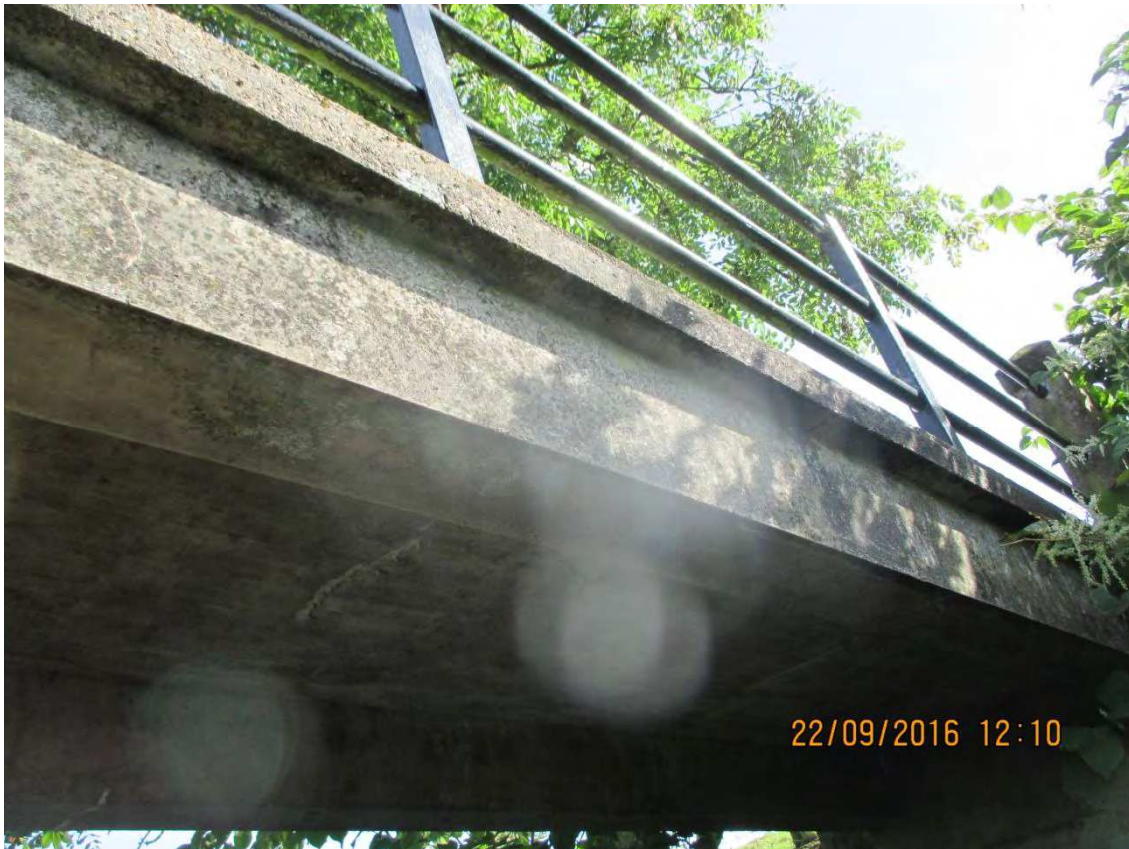
Photograph 45: Span 5- U/S Edge Beam.

- Upstream Beam (Photograph No. 45):
 1. Vertical hairline cracks are visible along the beam.
- Downstream Beam (Photograph No. 46):
 1. Vertical hairline cracks are visible along the beam.

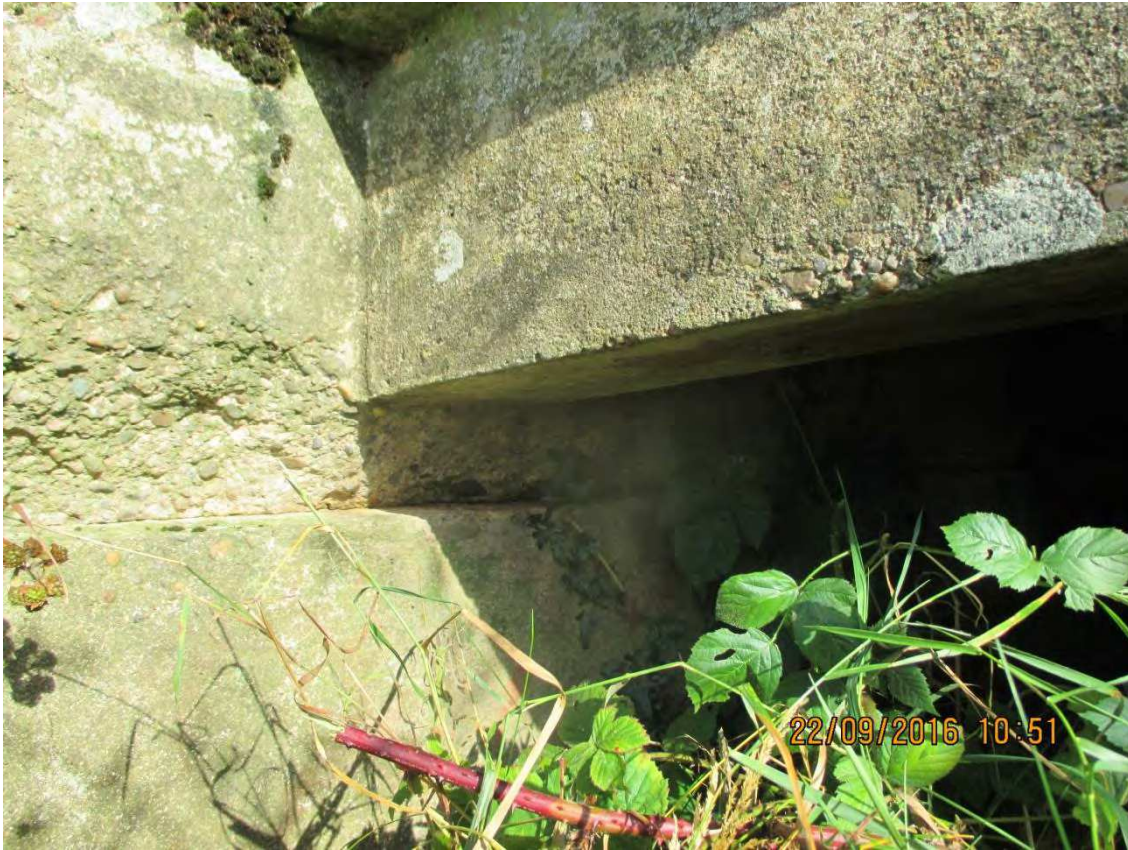
Photograph 47: Abutment 1 (West) Overview.

The abutment appears to be in relatively good condition, however there is minor concrete damage to the base of the abutment at bank-seat level. Reinforcement is not exposed.

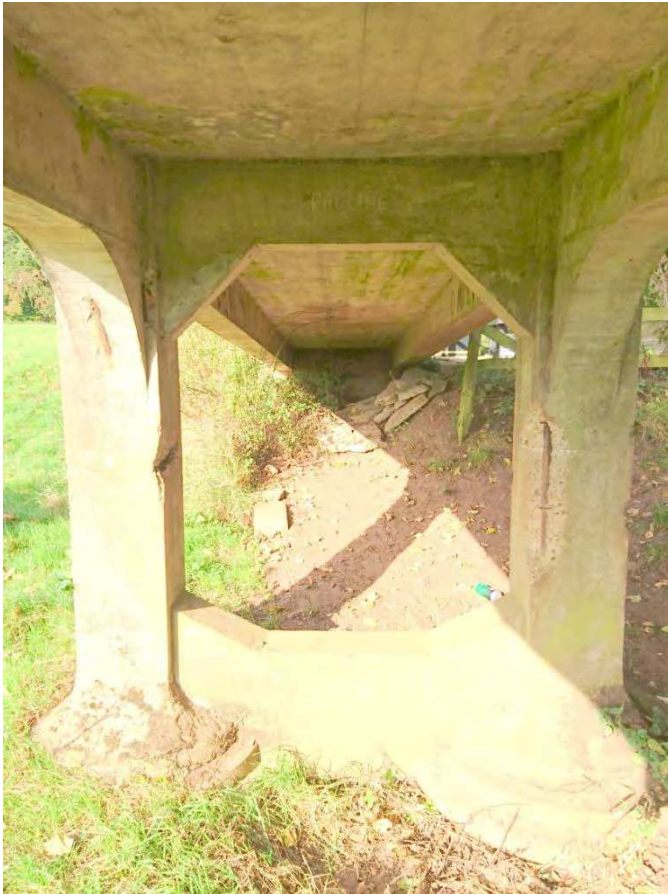
Photograph 49: Pier 1- Overview.

Photograph No. 49 shows the east elevation of Pier 1. Circular columns are not visible, however the decorative coping is.

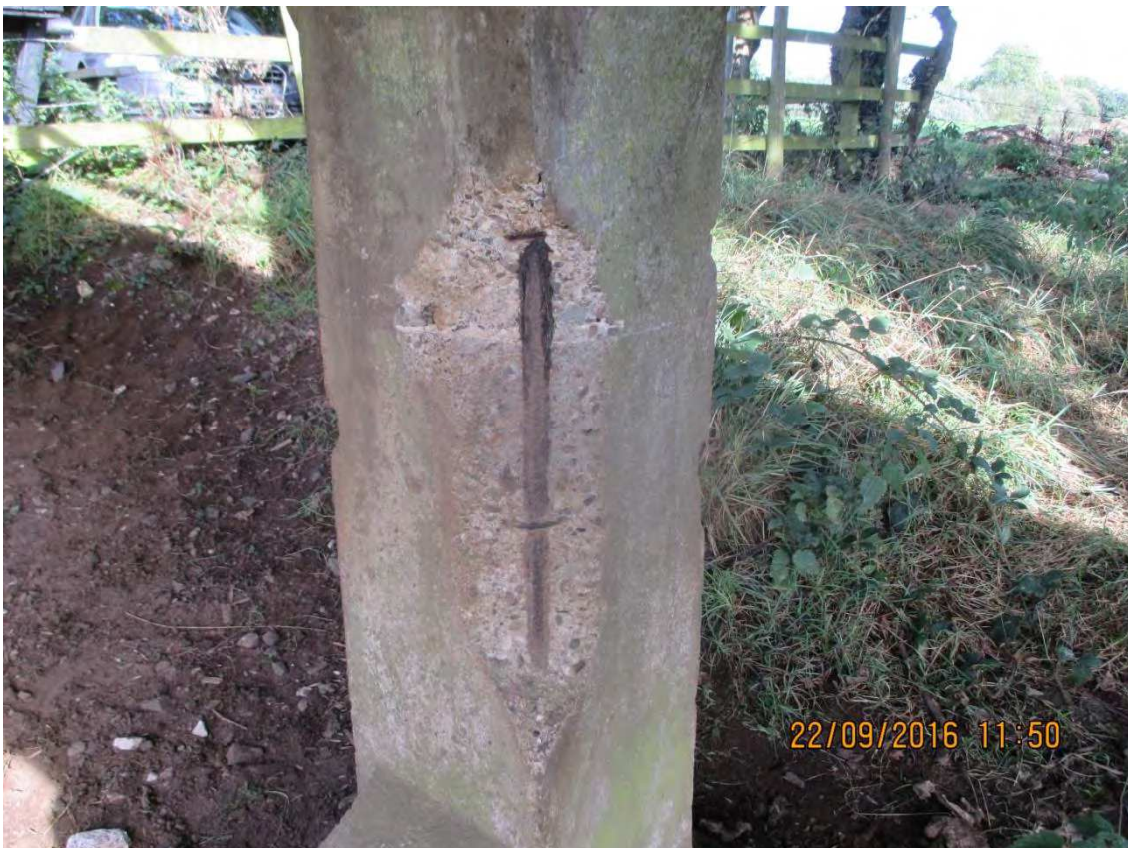
Photograph 50: Pier 1- Item 1a.

1. The four corners of the downstream column are damaged as detailed:
 - a. Photograph 50 SE- Damage is approx. 150mm x 500mm x 35mm deep. One reinforcing bar and two small diameter links are exposed; corrosion and section loss visible.
 - b. Photograph 51 NW- Damage is approx. 70mm x 400mm x 40mm deep. One reinforcing bar is exposed; corrosion and section loss visible.

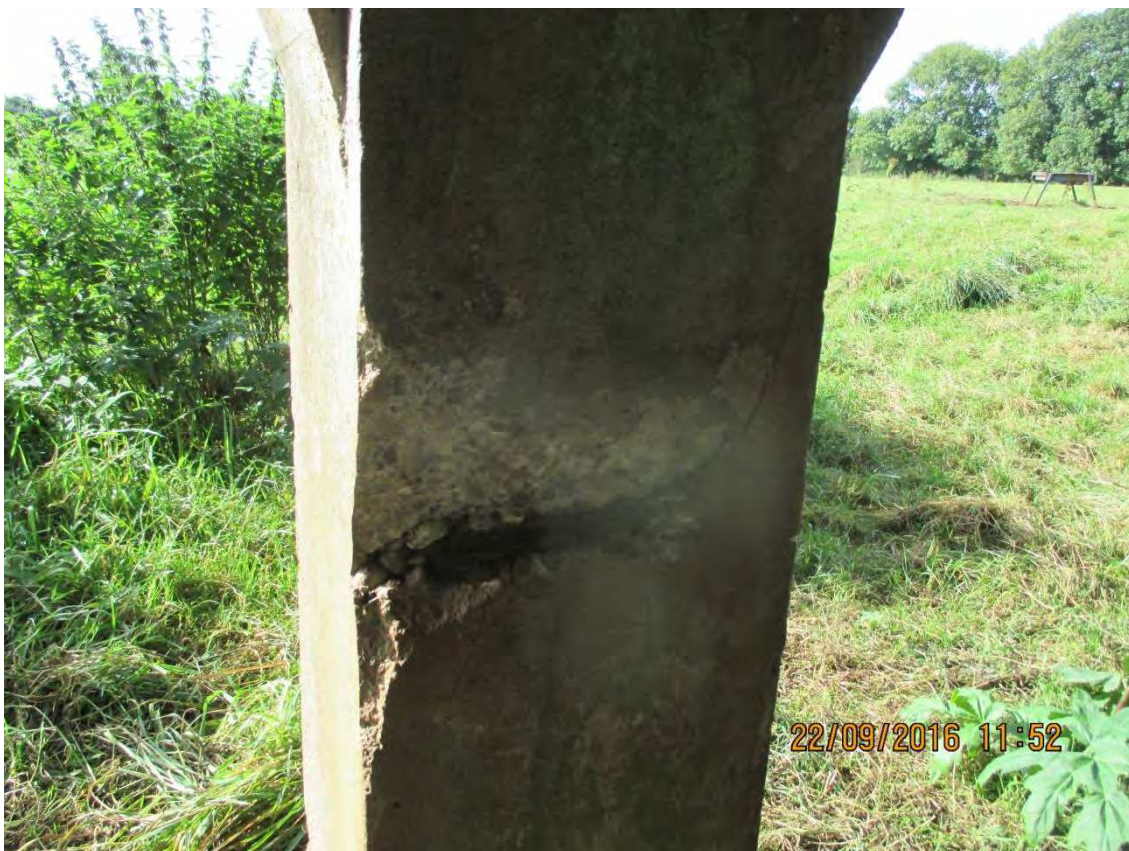
Photograph 52: Pier 1- Item 2a.

- a. Photograph 52- North face- Damage is approx. 200x70x 35mm deep. Three no. reinforcing bar links are exposed; corrosion and significant section loss visible.
- b. Photograph 53- East Face decorative section of beam- Damage is approx. 100x300x 10mm deep. One reinforcing bar is exposed; corrosion and section loss visible. Lack of cover.
- c. Photograph 54- North face- Minor concrete damage noted, 1 reinforcing bar exposed with minor corrosion and section loss visible. There is also evidence of a previous repair to the cross beam.

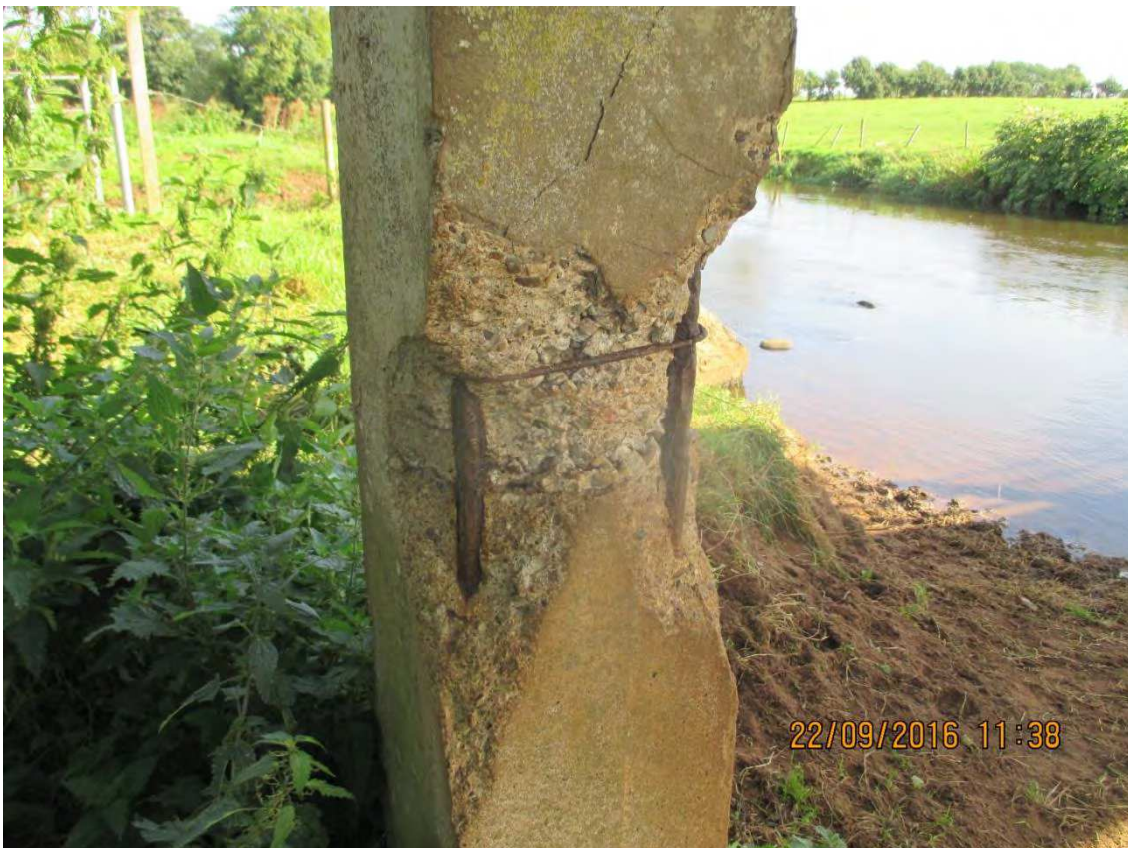
Photograph 56: Pier 2- Item 1a.

- a. Photograph No. 56 shows significant damage to the south face of this column- Damage is the full width of the column over 400mm and 60mm deep at the worst case. Two reinforcing bars and two small diameter links are exposed and corrosion and section loss visible.
- b. Photograph No. 57 shows concrete spalling and one exposed bar on the cross beam on the south face. One reinforcing bar is exposed and corrosion and section loss visible.

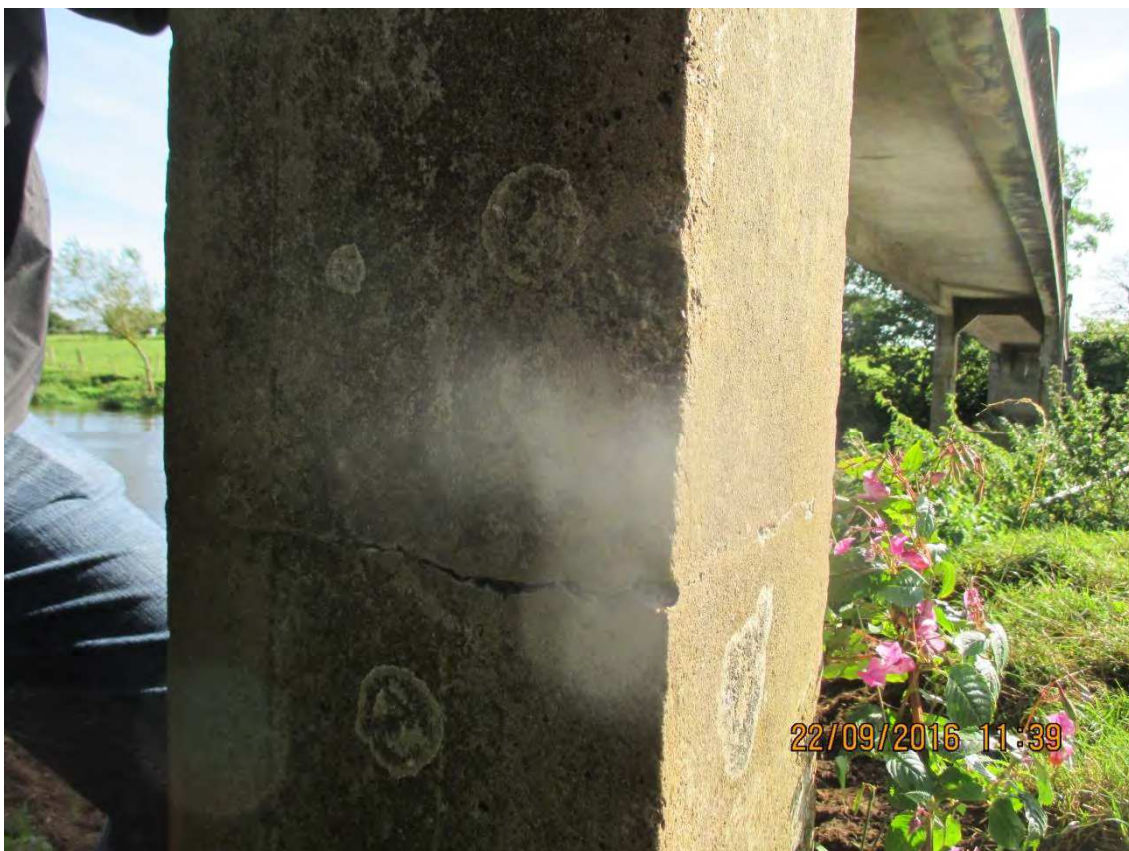
Photograph 58: Pier 2- Item 2a.

- a. Photograph 58 shows hairline cracking which continues around the perimeter of the column at approximately mid-height. This is possibly a construction joint, however, minor concrete damage is noted.

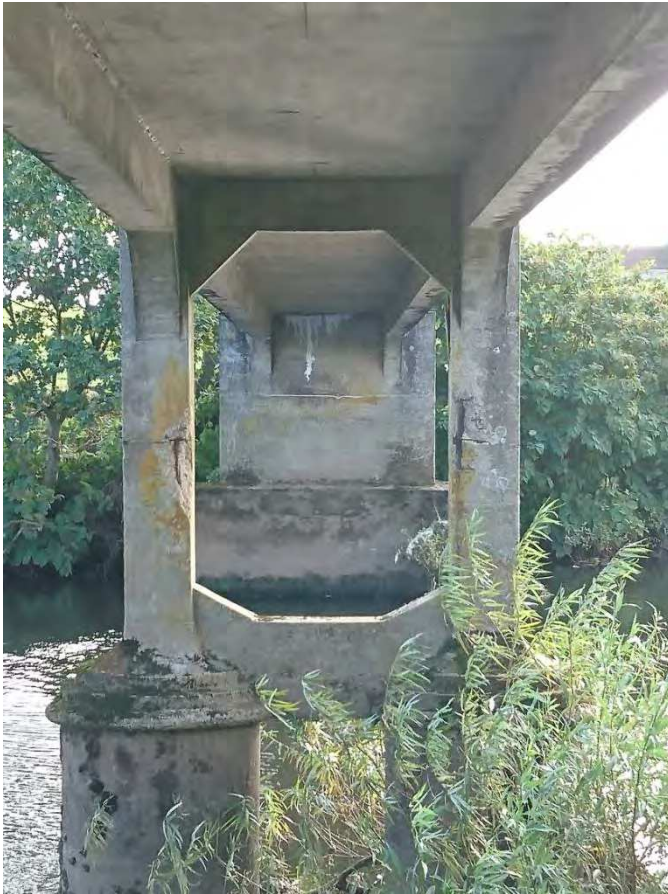
Photograph 59: Pier 3- Overview

Photograph No. 59 shows the west elevation of Pier 3. Access was not possible at the time of inspection, however damage was observed from the river bank

- 1. Photograph No. 59 shows damage to both the SW and NW corners of the downstream and upstream columns respectively. There is significant concrete

damage and reinforcement is exposed with corrosion and possible section loss.

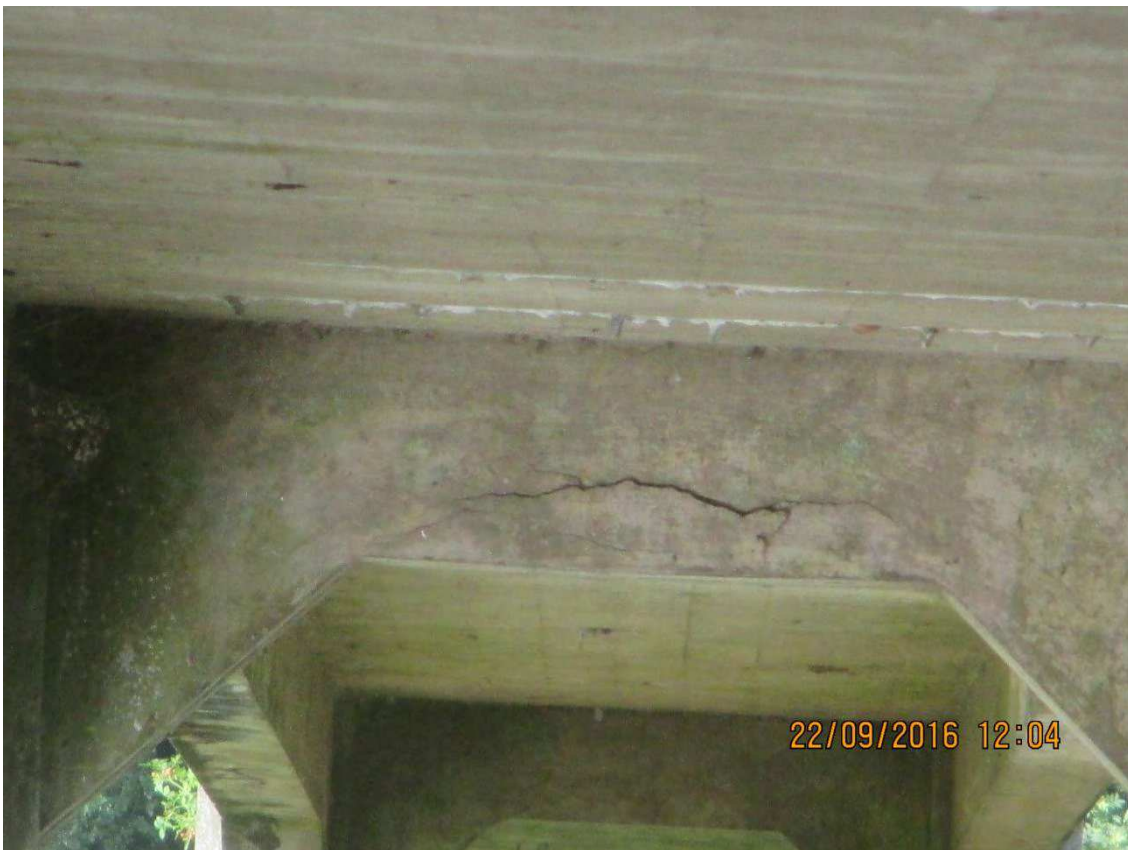
Photograph 60: Pier 3- Item 2.

2. Photograph No. 60 shows concrete damage on the upper cross beam on the east face of Pier 3.

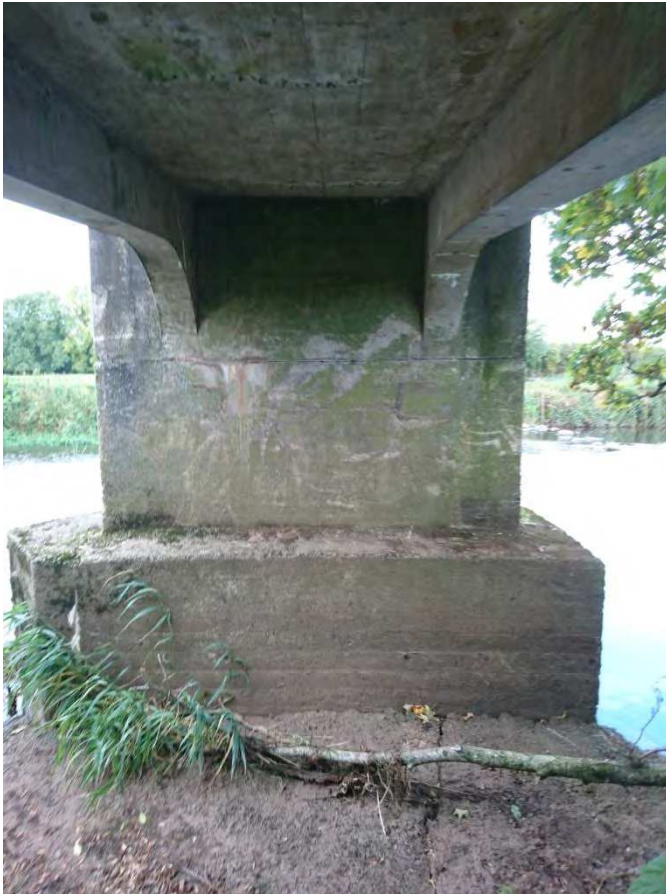
Photograph 61: Pier 4- Overview.

Photograph No. 61 shows the east elevation of Pier 4. As detailed this is a mass concrete pier.

There is scour to the riverbed at the SE corner of the pier, however, it was not possible to ascertain if the pier is being undermined at this stage.
