Comhairle Ceantair
Lár Uladh
Mid Ulster
District Council

COTT LANE FOOTBRIDGE
PRINCIPAL INSPECTION REPORT

Project No	Revision	Prepared by	Checked by	Approved by	Status	Date
16/140C	1	PDD	TS	TS	FINAL	24/10/2016

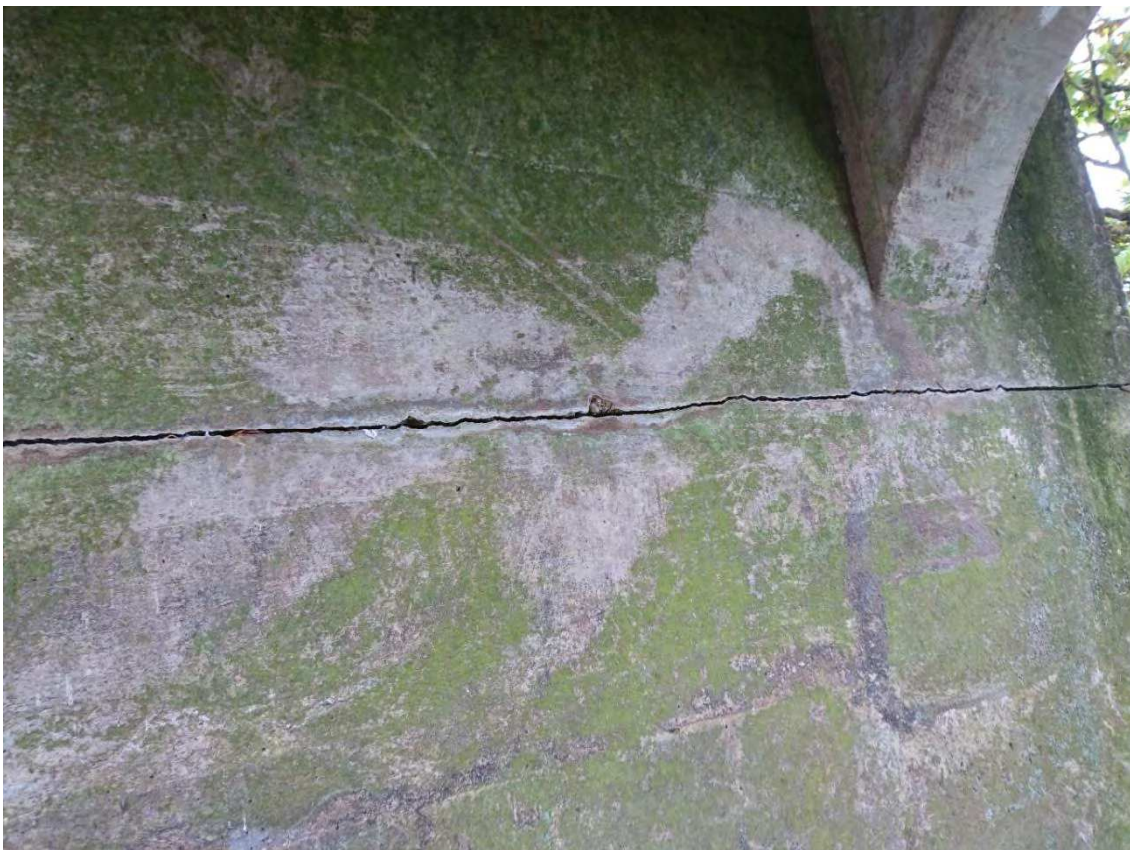
Photograph 62: Pier 4- Item 1.

1. Photograph No. 62 shows a crack on the pier face. The crack continues around the perimeter of the pier. The crack is approx. 5mm on the east face and hairline on the west face.

- 5.4 Decorative Piers 1, 2 & 3 all exhibit significant concrete damage around the midpoint on the upper square columns. This may indicate horizontal movement of the bridge structure. The mass concrete Pier No. 4 is cracked around its perimeter on the upper half of the pier.

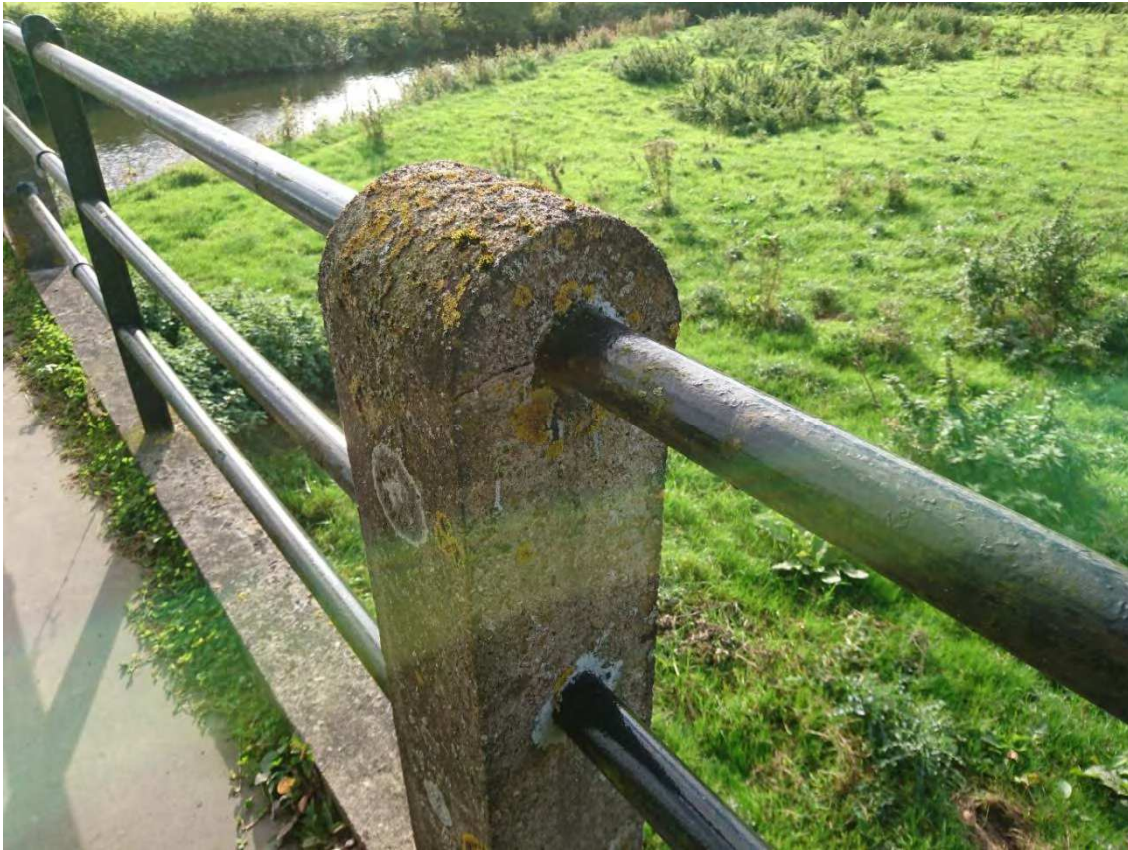
Photograph 65: Parapet- Item 2.

1. Photograph No. 64 shows concrete damage to the top of a concrete pillar.
2. Photograph No. 65 shows a crack to the top of the concrete pillar corresponding with the top hand rail.

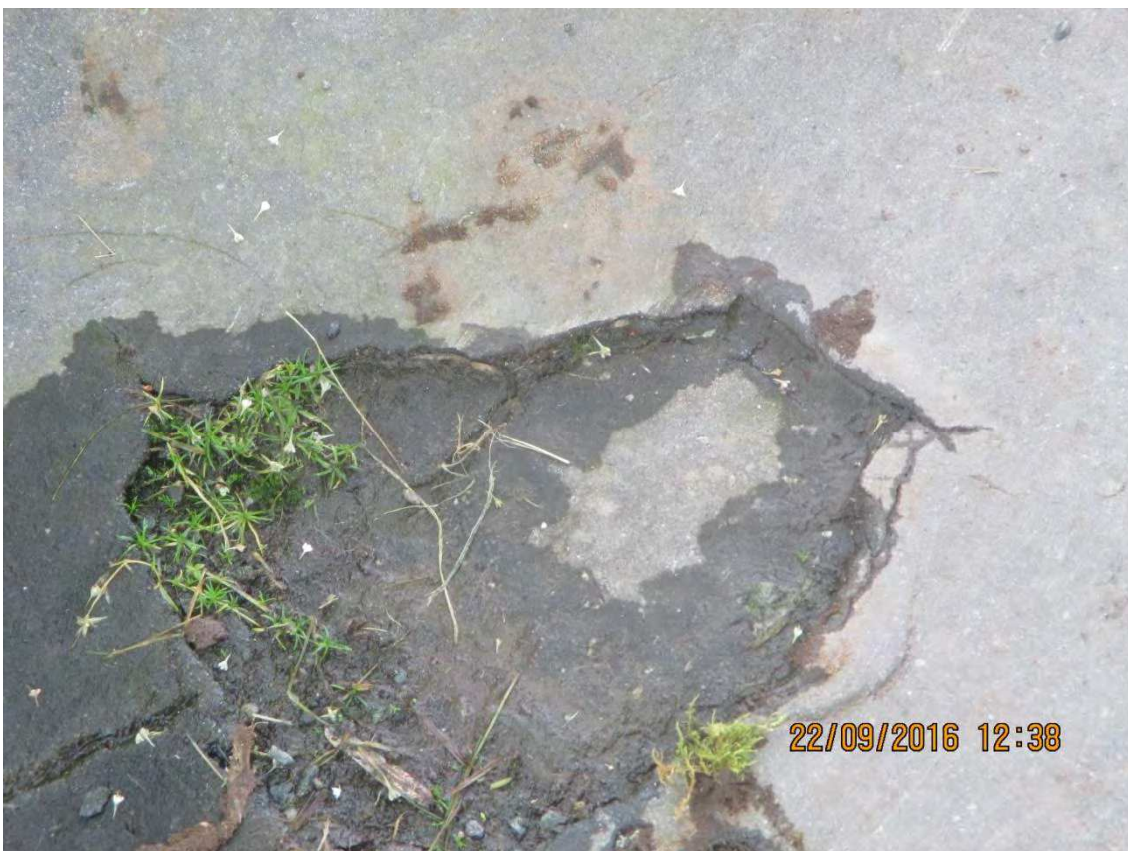
Photograph 66: Surfacing Damage.

There are isolated locations where this surfacing is damaged. Photograph 66 provides an example of this damage.

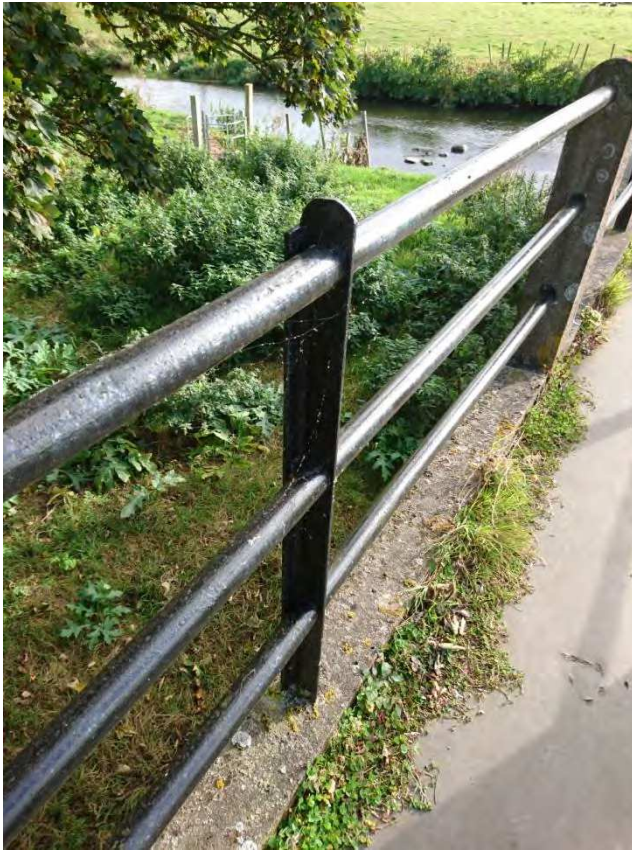
Photograph 67: Vegetation Growth.

There is vegetation growth along the edge of surfacing and plinth over the entire length of the footbridge (see Photograph 67).
