**Independent
Reference
Group**

Fire Safety in Housing Executive Tower Blocks

Findings Report

JANUARY 2018

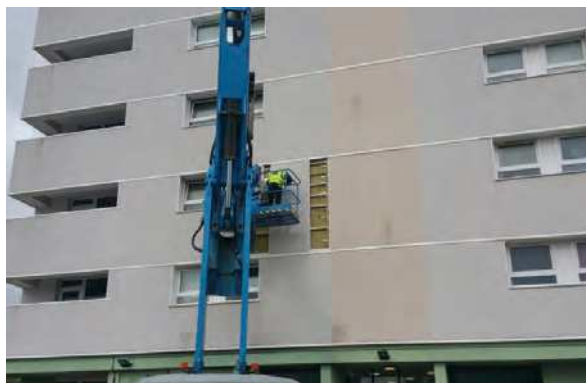
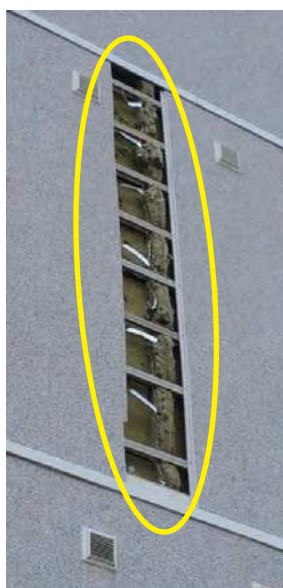
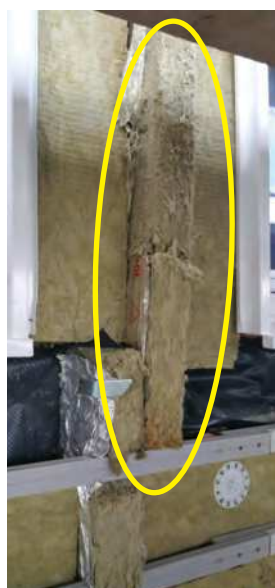
Evidence of 'opening up' and presence of vertical firebreaks in regard to Cúchulainn and Whincroft House tower blocks
