COOKSTOWN PUBLIC REALM

JUNE 2021 INSPECTION

TECHNICAL SERVICES REPORT

MUDC T.S REF: MUDC/TS/C/2015/028

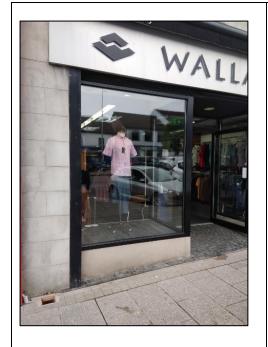
William Street

Gully cover missing which is a potential trip hazard.

DFI to inform the contractor/owner to install gully lid to prevent trip hazard.

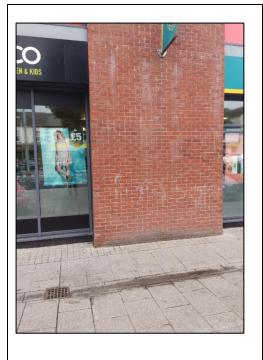
James Street

Slight depression in the paving close to the gully location preventing water reaching the gully.

DFI roads term contractor to install gully at low point to catch water. Area to be monitored for further settlement.

Public Realm contractor to be notified of potential latent defect.

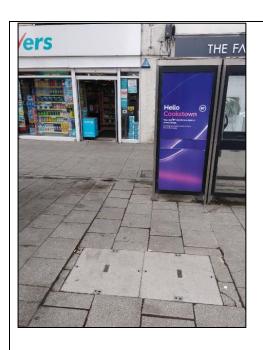
Close proximity photo of issue above.

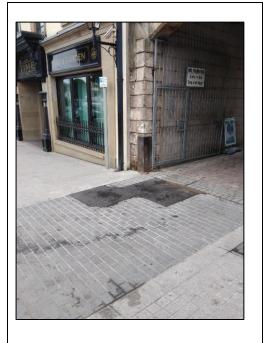
James Street

Recent utility works completed. Temporary blacktop installed.

DFI roads to review records and determine who carried out the works.

To be monitored to ensure paving is reinstated back to the standard of the public realm.

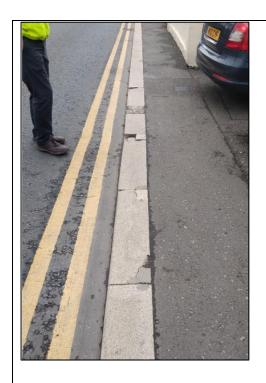
Burn Road

Numerous kerbs chipped.

Potential causes appear to be the constant vehicular traffic they get due to the narrow road and also multiple entrances. Council to confirm spares are available from EI Scheme and liaise with Dfl.

Dfl to replace kerbs.
