Seyloran Lane, Dungannon

Our Ref: MU/SS/102 Date: 14th October '21

Re: Seyloran Lane Bridge

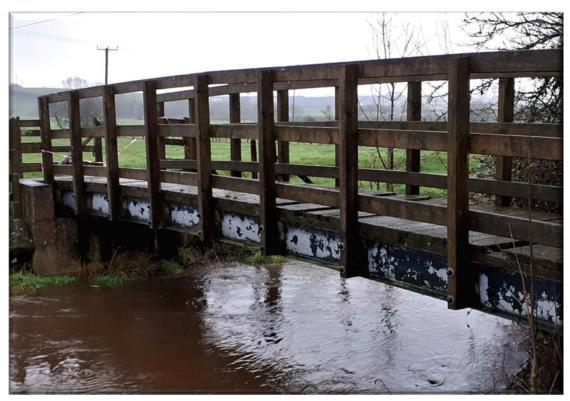
Fig 1 Side elevation of Bridge

Dept. of Agriculture/Rivers Agency to provide pedestrian access on a right of way. It is a steel framed/timber deck structure, 10m span x 1.5m wide.

The steel beams, supporting the bridge decking, are in robust order, with no evidence of structural deterioration. The foundation blocks, supporting the structure, are also in robust order. The timber decking, however, does exhibit considerable structural deterioration - as may be expected with such material (Design life 15-20 years). A full replacement of the decking is required at this time. Also, some of the timber handrails/posts may merit replacement, due to their current condition.

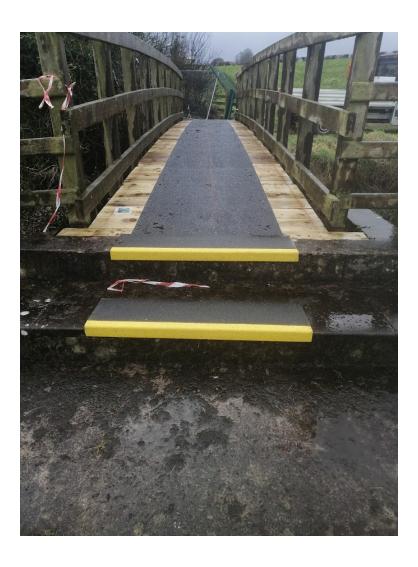
PS A recent photo has been provided, showing full replacement of timber decking, with antislip central covering- provided by DfI Rivers, as I understand.

Seyloran Lane/ River Rhone Bridge Refurbishment Works completed by Dfl Rivers 2021
