Comhairle Ceantair
Lár Uladh
Mid Ulster
District Council

COTT LANE FOOTBRIDGE
PRINCIPAL INSPECTION REPORT

Project No	Revision	Prepared by	Checked by	Approved by	Status	Date
16/140C	1	PDD	TS	TS	FINAL	24/10/2016

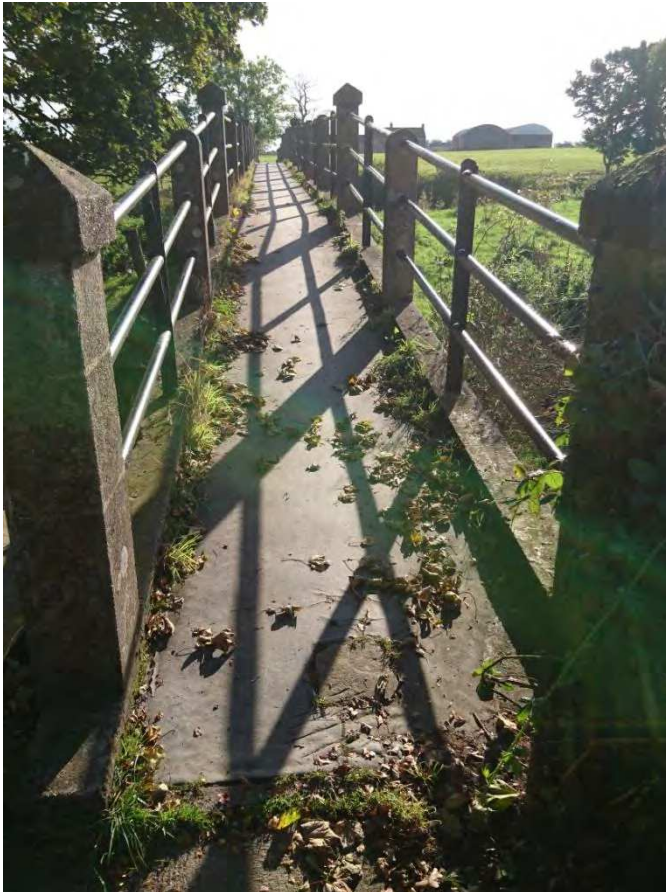
Photograph 1: Approach from west

- 2.1 Cott Lane footbridge crosses the Ballinderry River approximately 1.0km from where the river enters Lough Neagh. Photograph No. 1 shows the bridge approach from the west and Photograph No. 2 from the east.

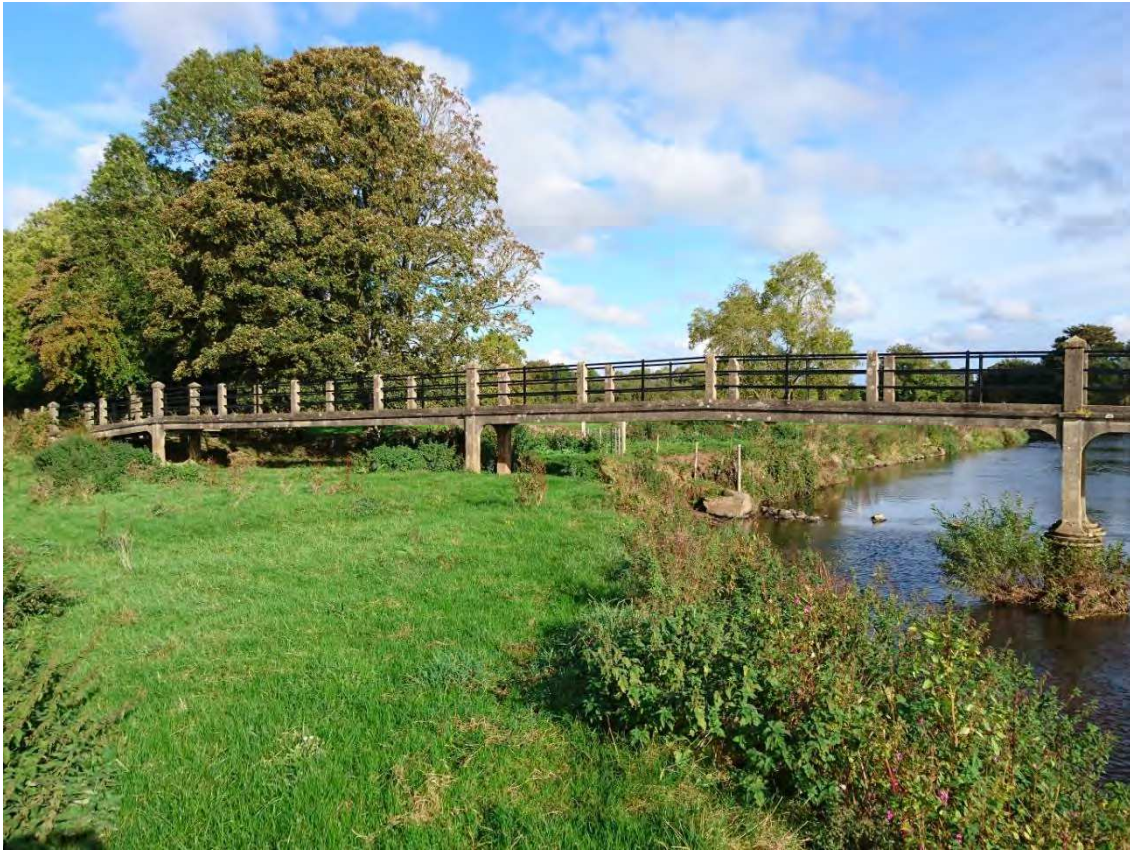
Photograph 3: South Elevation (west).

- 3.1 The bridge is a five span reinforced concrete structure, Photograph No's 3 & 4 show a view of the south upstream (U/S) elevation and Photograph No's 5 & 6 a view of the north downstream (D/S) elevation. The bridge comprises of 2 No. reinforced concrete edge beams supporting a reinforced concrete deck and supported on concrete abutments and piers. Steel parapet railing is supported by a mixture of concrete pillars and steel posts. There is no detailed information of the bridge construction available and at this stage it is not possible to ascertain the formation level of the concrete piers or abutments.

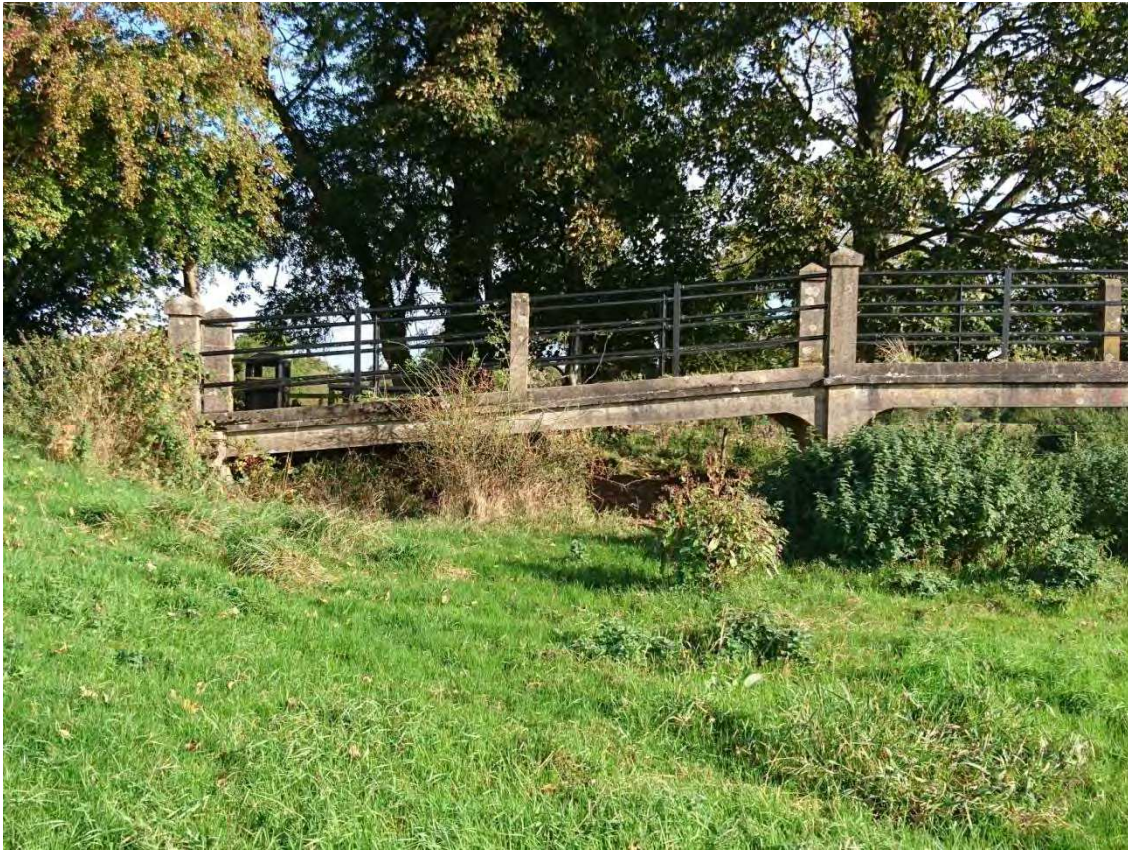
Photograph 7: Span 1- U/S Overview

4.1.1.1 SPAN 1 (Photograph No. 7)

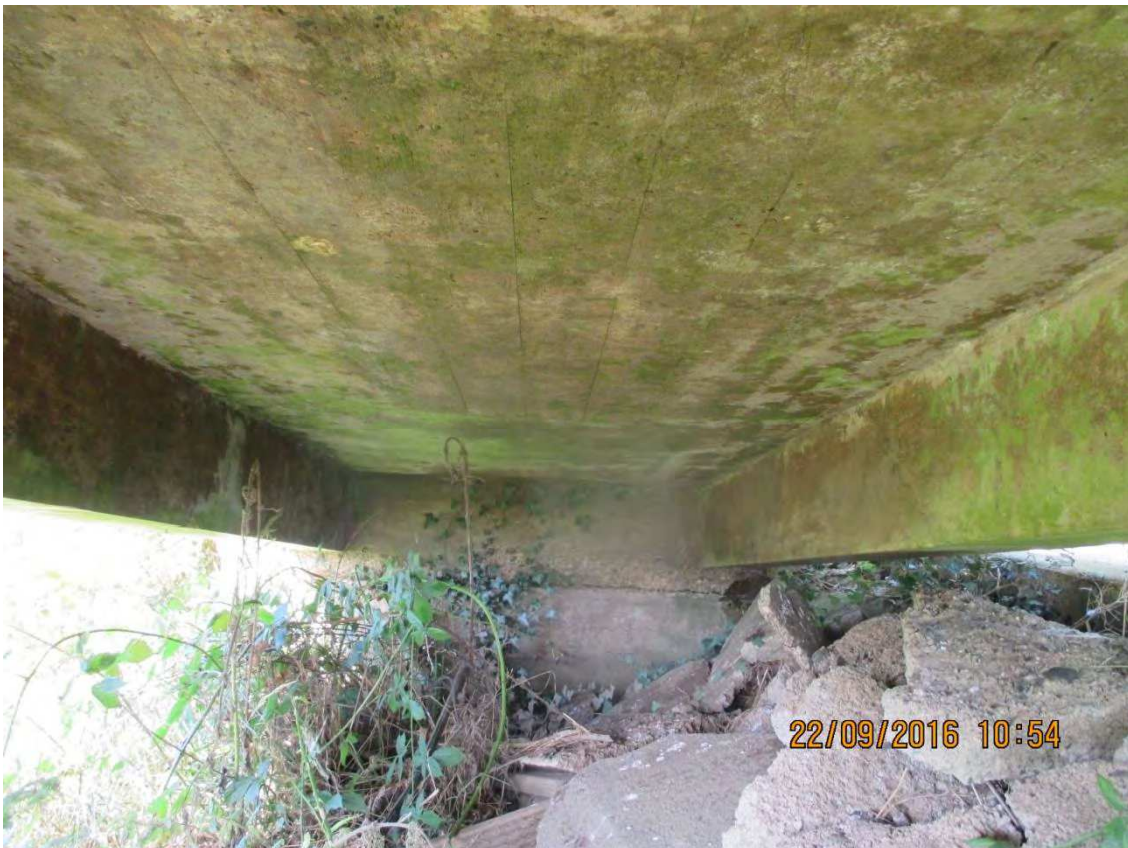
Photograph 8: Span 1- Deck overview

Deck (Photograph No. 8):

1. Slight water ingress was noted at one location. There are other locations where water staining is visible.
2. 3.2m from Abutment 1 (Photograph No. 9)- Concrete spalling; area approx. 80x80x20mm deep. One reinforcing bar is exposed; corrosion is visible with slight loss of section.
3. 3.9m from abutment 1(Photograph No. 10)- Concrete spalling; area approx. 100x50x20mm deep. One reinforcing bar is exposed; corrosion is visible with minimal loss of section.
4. At Pier No.1- area approx. 200x90x20mm deep (Photograph No. 11). One reinforcing bar is exposed; corrosion is visible with significant loss of section.
5. There is minor concrete damage on the edge of the deck slab at 2 No. locations on the downstream face, see Photograph No's 12 & 13, one reinforcing bar is exposed at each location with minor corrosion visible.

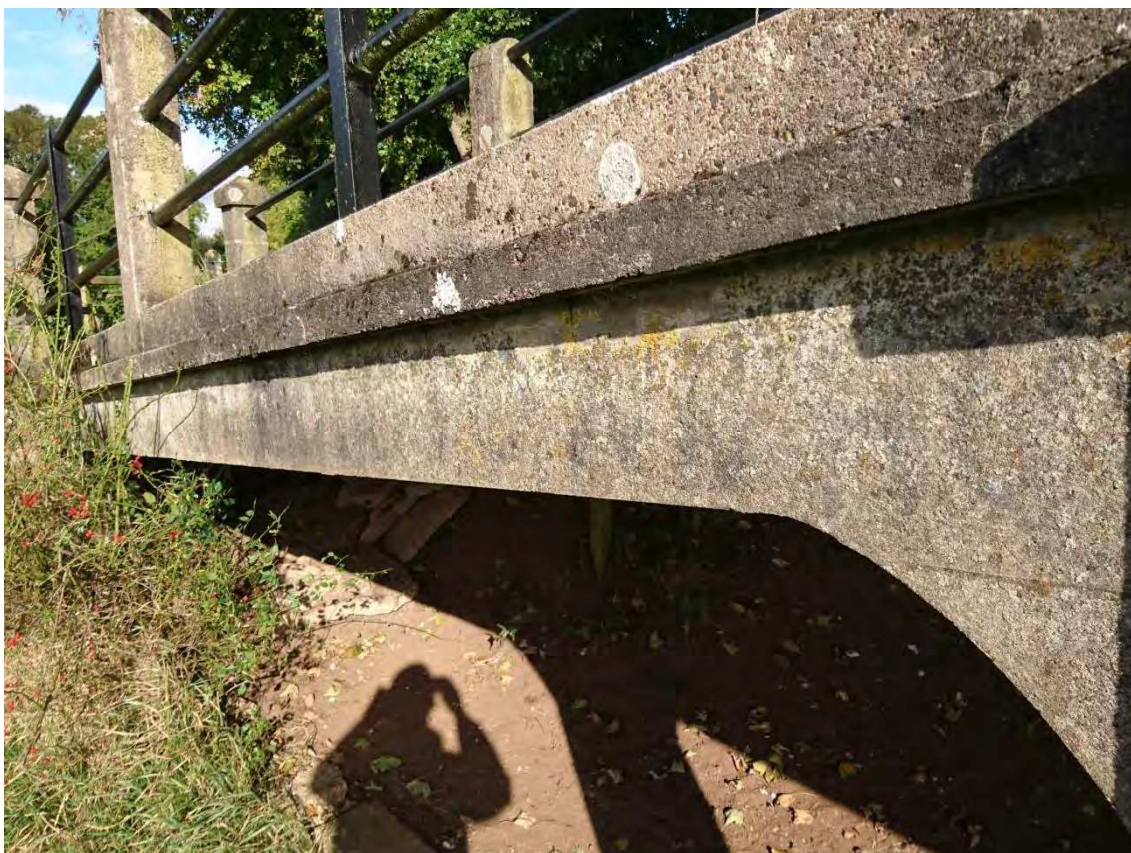
Photograph 14: U/S Edge Beam

Edge Beams (U/S-Photograph 14, D/S-Photograph 15):

1. Both beams appear to be in good condition with no significant defects identified.

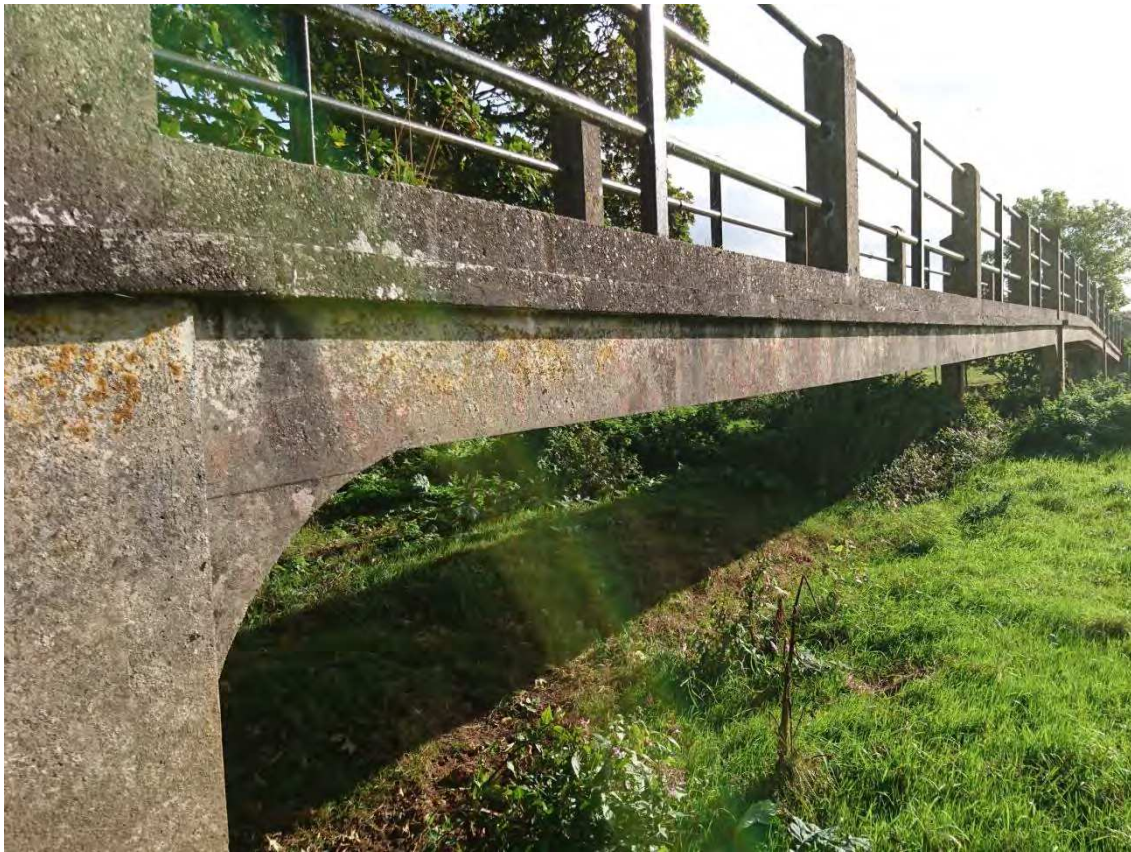
Photograph 23: Span 2- U/S Edge Beam

- Upstream Beam (Photograph No. 23):
 1. 13.0m from Pier 1(Photograph No. 24) 0112- Minor concrete damage at bottom of beam approx. 200x20x15mm deep.
- Downstream Beam (Photograph No. 25):
 1. Water staining visible at 2 locations on beam.

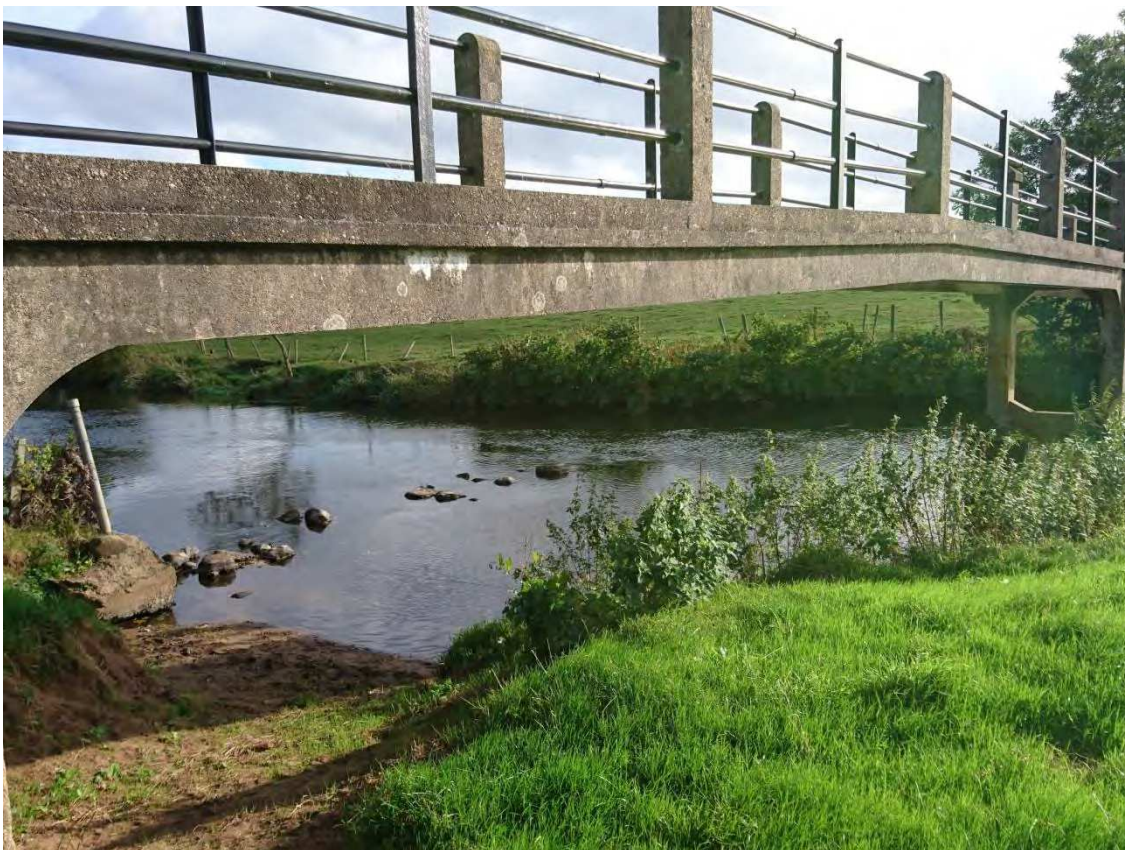
Photograph 32: Span 3- U/S Edge Beam Overview.

- Upstream Beam (Photograph No. 32):
 1. No significant damage identified.
- Downstream Beam (Photograph 33):
 1. 5.7m from Pier 2 (Photograph No. 34)- Significant concrete spalling/ damage; area of approx. 600 long x 200x50-70mm deep. Two reinforcing bars are exposed; corrosion is visible with loss of section.
 2. 7.2m from Pier 2 (Photograph No. 35)- Concrete spalling; area of approx. 300mm long x200x50mm deep. One reinforcing bar is exposed; corrosion is visible with loss of section.

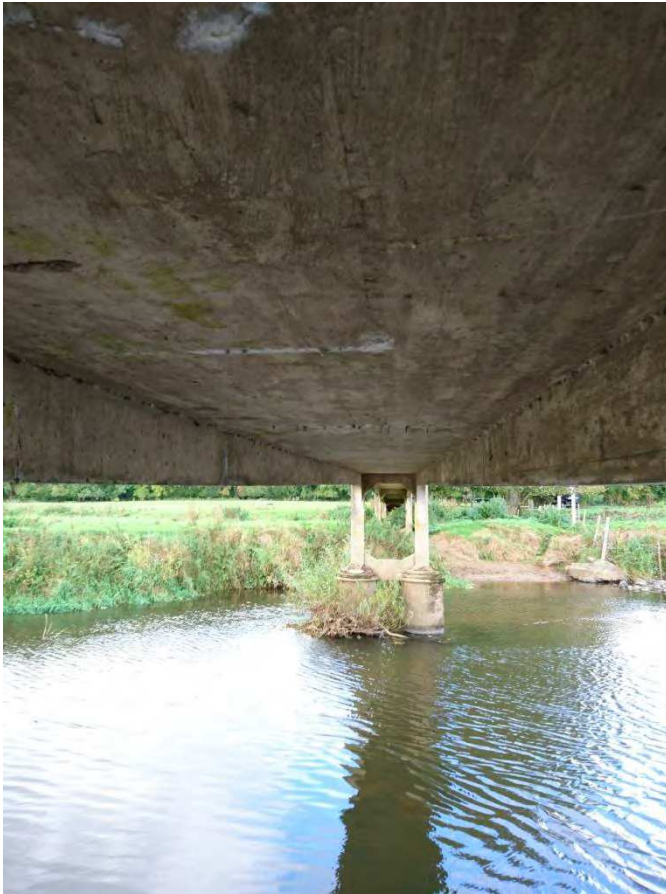
Photograph 37: Span 4- Deck Overview.

Deck (Photograph No. 37):

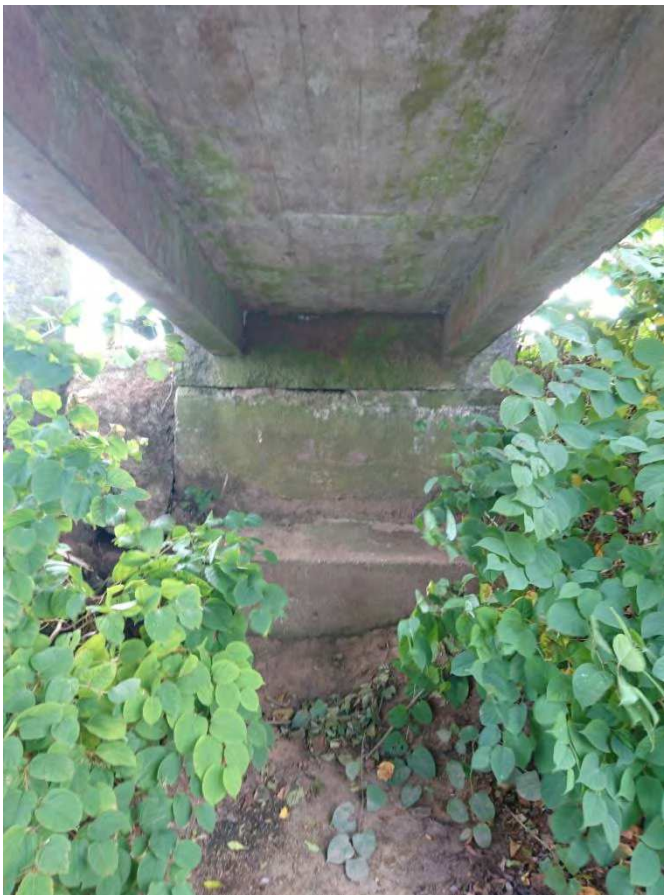
Photograph 48: Abutment 2 (East) Overview.

4.2.2.2 **Abutment 2** (East) See Photograph No. 48:

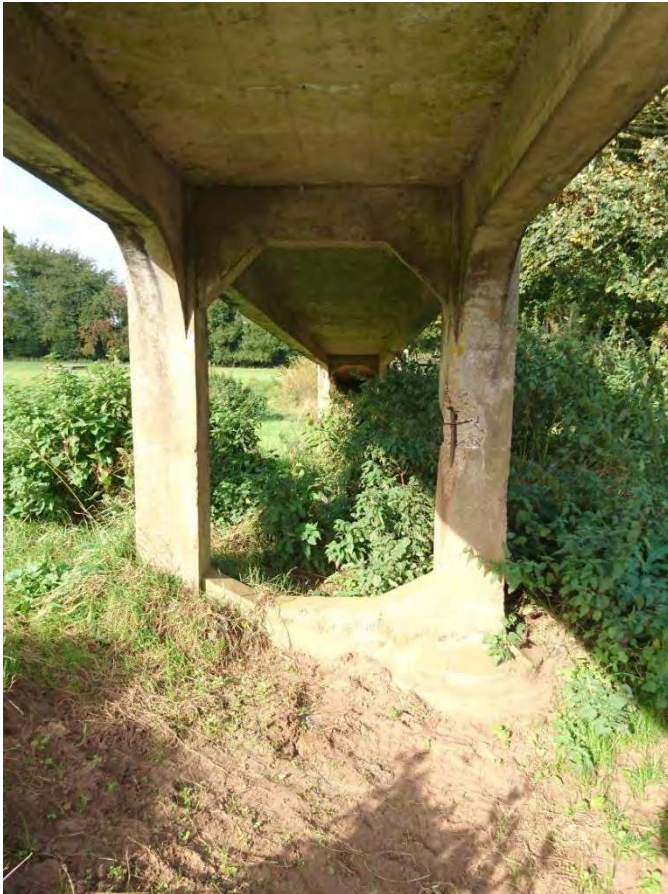
Photograph 55: Pier 2- Overview

Photograph No. 55 shows the east elevation of Pier 2.

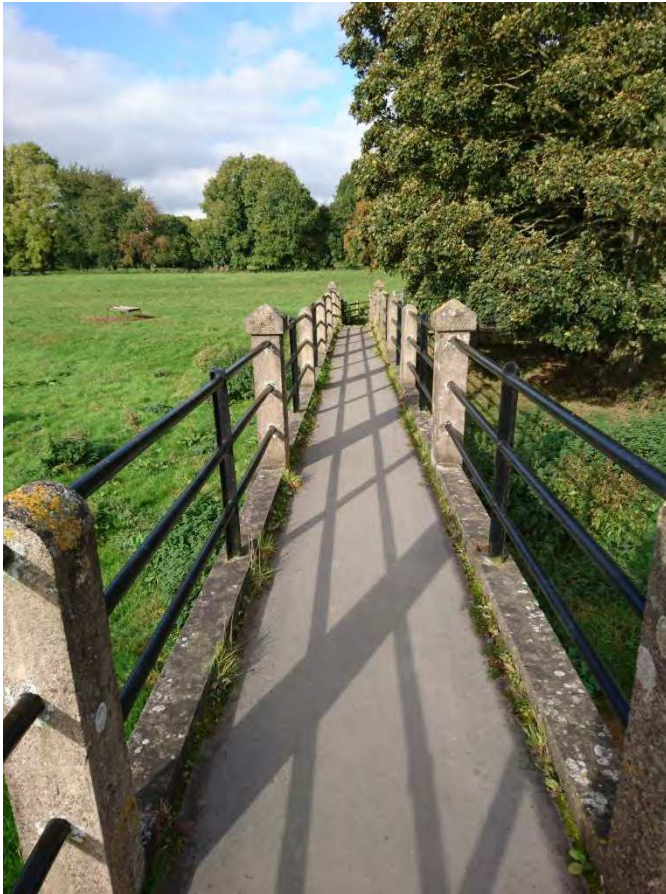
Photograph 63: Parapet- Overview.

Parapets consist of metal handrails with alternate concrete and steel pillars/posts. (see Photograph No. 63) The parapet hand rails are generally in good condition. There is however some minor damage:

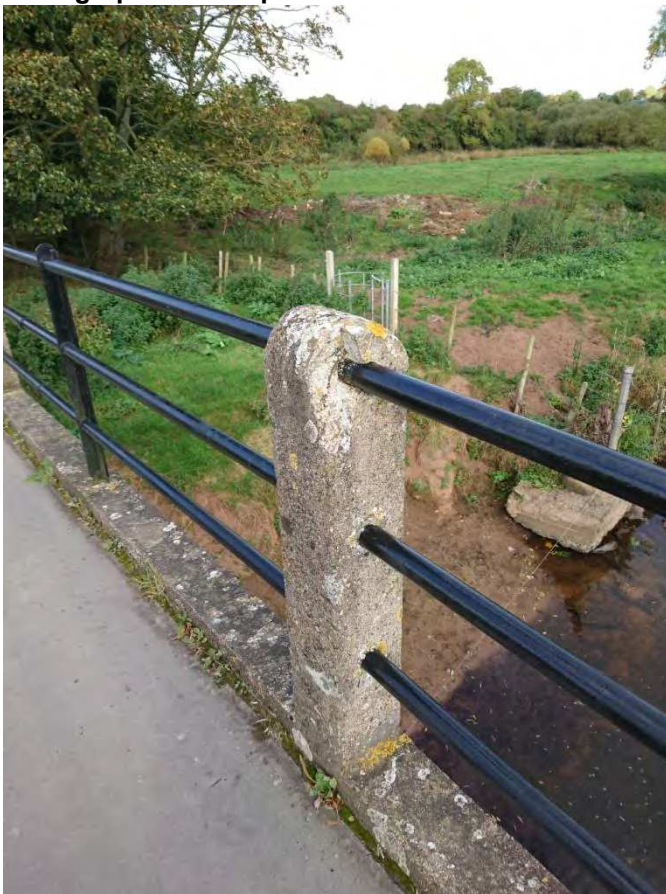
Photograph 64: Parapet- Item 1.

1. Photograph No. 64 shows concrete damage to the top of a concrete pillar.
2. Photograph No. 65 shows a crack to the top of the concrete pillar corresponding with the top hand rail.
