Report on	Report on 'Heritage at Risk in Northern Ireland – Review and Recommendations' and 'Heritage at Risk in Northern Ireland. Heritage buildings & structures at risk within Mid Ulster District Council
Date of Meeting	4 th June 2019
Reporting Officer	Sinead McEvoy
Contact Officer	Chris Boomer

REVIEW AND RECOMMENDATIONS

January 2019

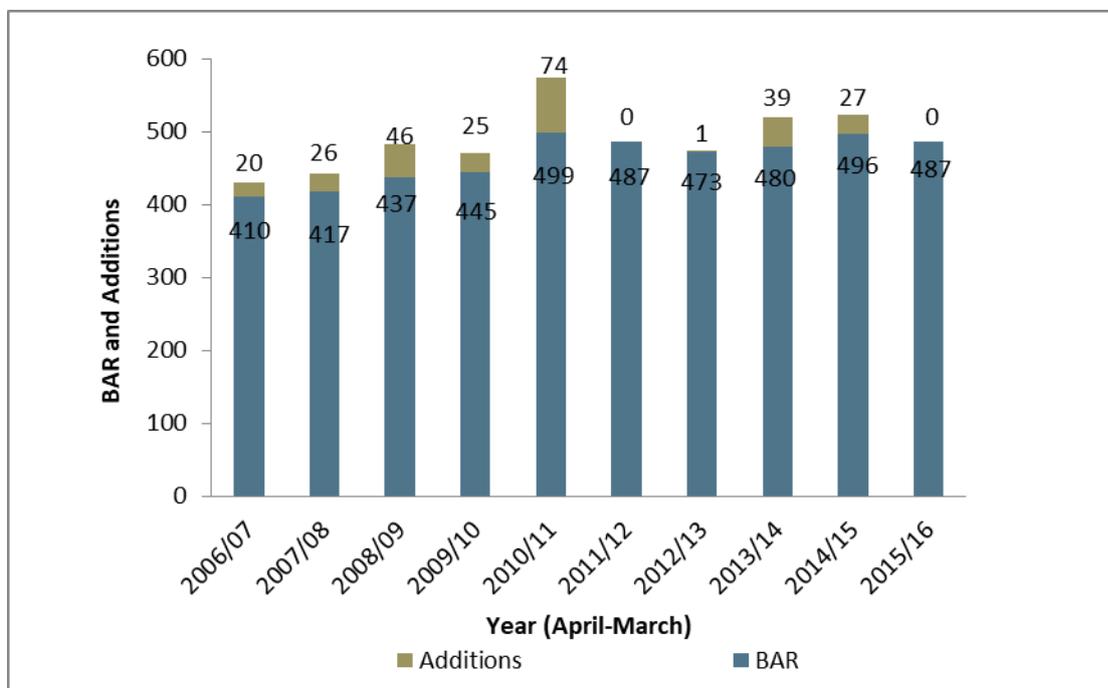
Figure Total Heritage and numbers added to the at risk register 2006-16.

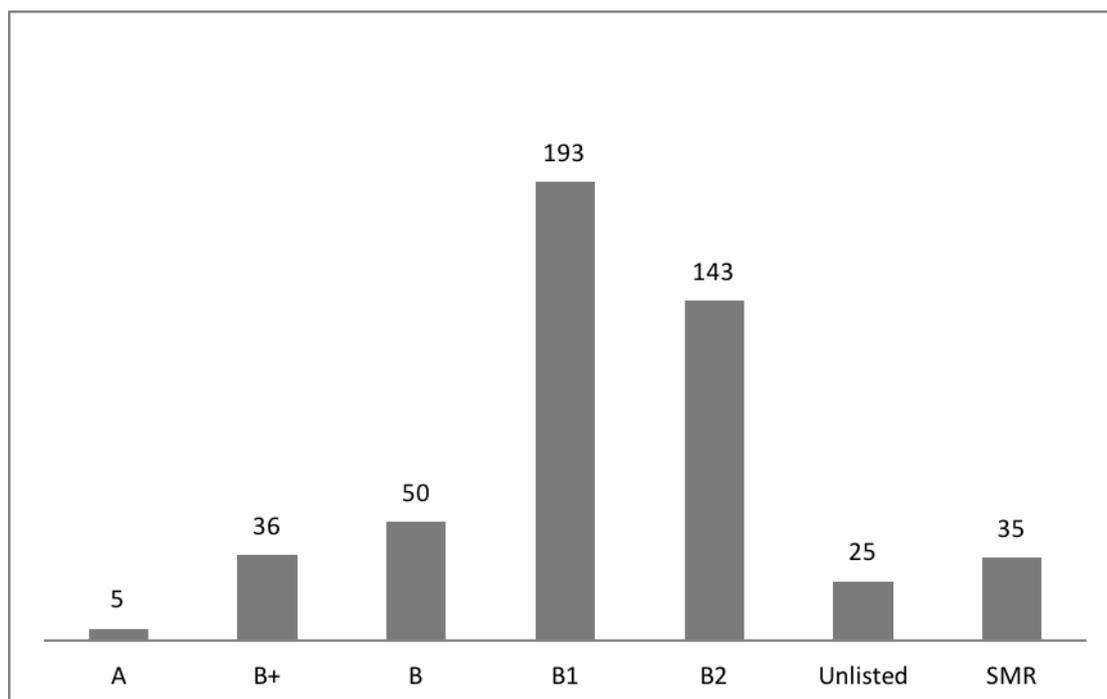
There are currently 5 Grade A heritage assets included on the BHARNI register, equating to approximately 1%. Grade A buildings represent the buildings of the greatest importance to Northern Ireland and are likely to include outstanding architectural features or national or international importance.

Scheduled monuments currently account for a relatively small number of entries. It is anticipated that more scheduled monuments will be included on the Register. This will bring it into line with similar heritage at risk registers in the UK.

BHARNI entries by grade of protection

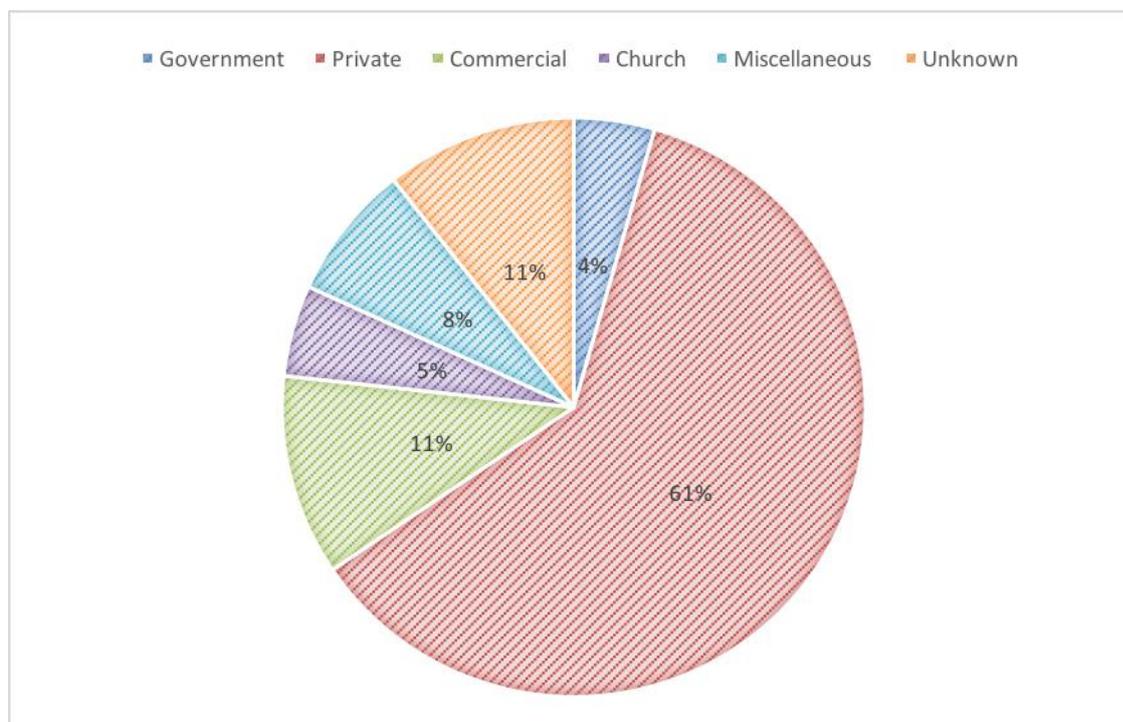
The ownership category analysis of BHARNI structures reveals a fairly consistent picture. The majority (61%) are in private ownership; structures in commercial and church ownership account for 16%; while government, both central and local, is responsible for 8%. Different types of owners can face different challenges and opportunities in caring for and protecting historic buildings. This may in addition be related to 'Type', 'Location', and 'Funding' as outlined below.

BHARNI entries by ownership.

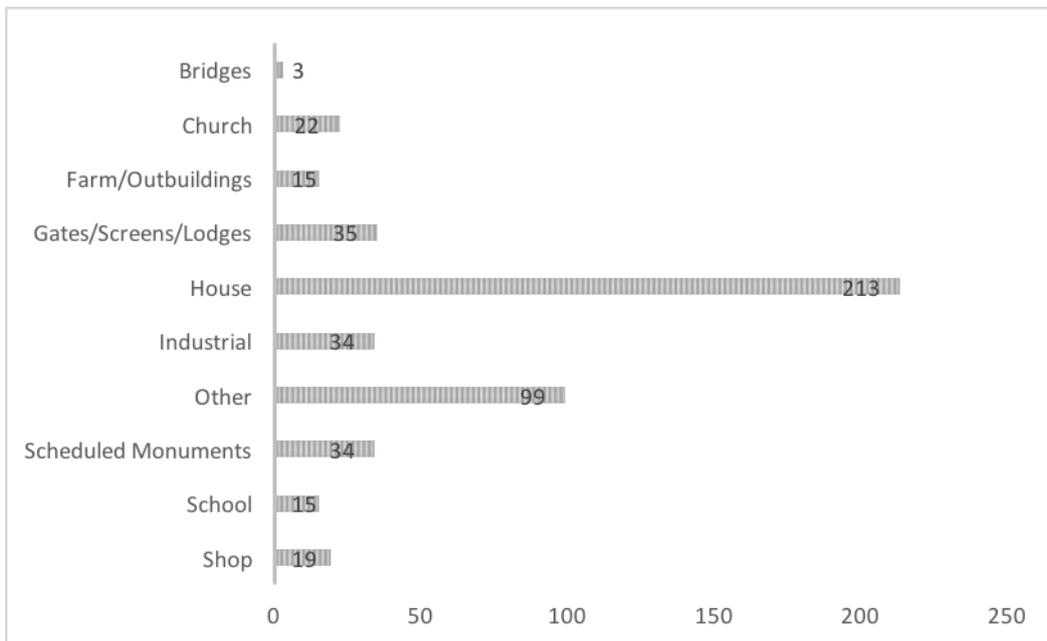
Approximately 40% of all buildings at risk fall within the use category of *house*. This figure does not distinguish between rural/urban/large or small house but they have all been habitable at some point and should lead themselves to sympathetic development. This would appear to correspond with the level of private ownership described above. No other type category makes it into double figures, but *Scheduled Monuments*, *Gate/Screens/Lodges* and *Industrial* buildings also account for a fairly substantial minority of entries. A whole range of other categories are accounted for but at much lower frequencies within the *other* category. This demonstrates the wide variety of heritage assets that have become vulnerable and are in need of a new use or bespoke programme of maintenance.

BHARNI entries by building use (HED).

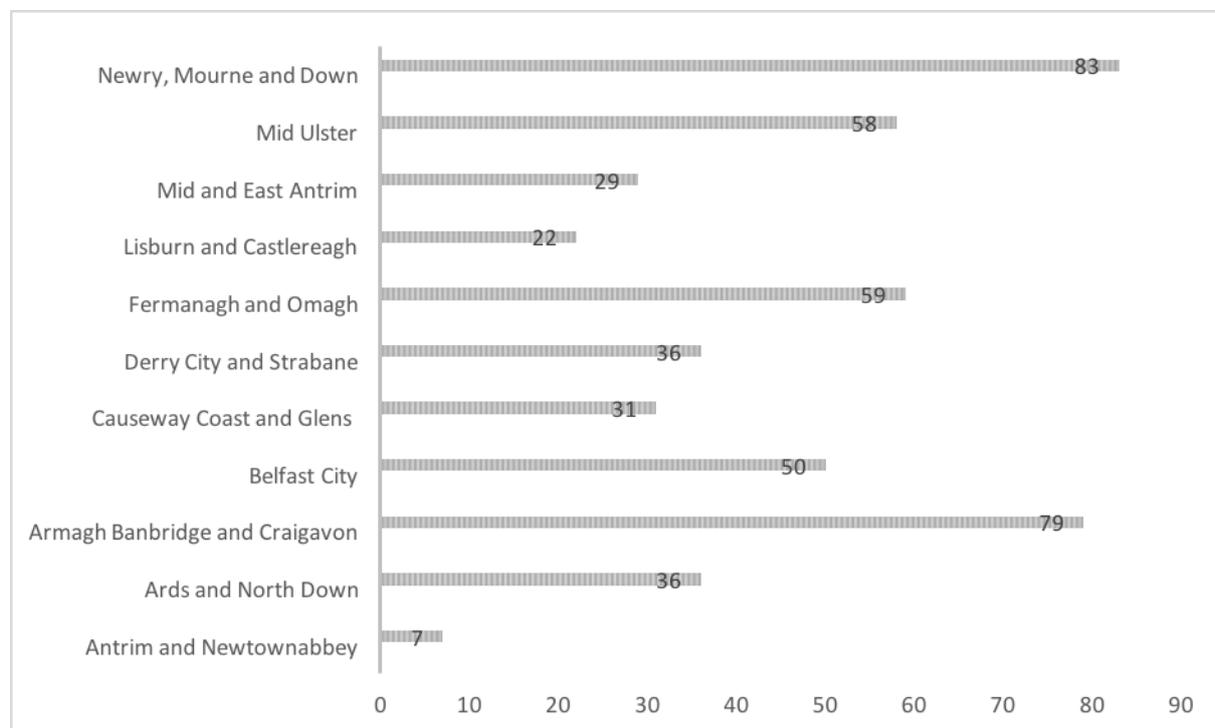
Note: The areas of concentration for BHARNI may fluctuate as the second survey of listed buildings moves around Northern Ireland, highlighting new vulnerable structures. Due to the register being based on 'known' data, together with delay in the process of the second survey, it should be noted that some parts of Northern Ireland may not have been recently surveyed.

BHARNI entries by Council Area.

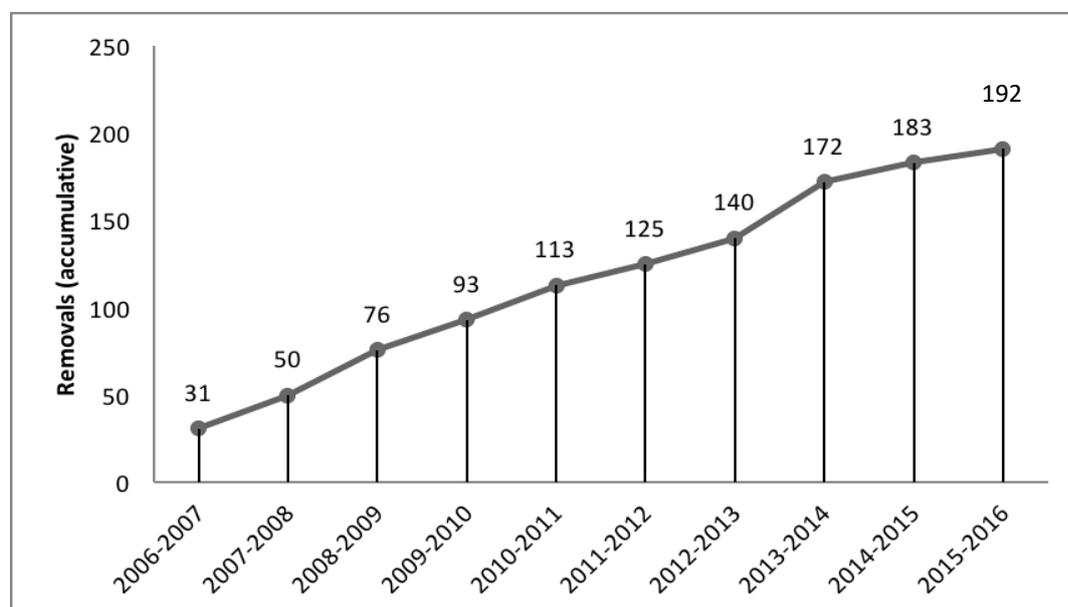
Between 2006 and 16 there has been an average rate of approximately 20 removals per annum. Most removals were recorded in 2013-14 when 32 buildings were saved. This corresponds with the year that listed building grant aid was at its highest, with a total spend of £4.6 million and a specific spend of 1,407k on buildings a risk. This may be taken to suggest a link between the rate of removals and the availability and level of grant aid. Another slight increase in removals was seen in 2008 and this may be interpreted to be due to the introduction of acquisition grant, or letters issued to owners. However, it is most likely related to the extended the availability of grant aid to B2 listed buildings that year.

Heritage removed from the at risk register 2006-2016.

Least removals were recorded in 2014/15 and 2015/16 where 11 and 8 buildings were removed respectively. The significant reduction in 2014/15 period corresponds with announcement of cut backs to the availability of listed building grants, amidst proposal of cessation of listed building grants in the draft budget for 2015/16. In 2015/16 a significant reduction in removals remained, corresponding with the complete suspension of listed building grants by HED. This period has also seen the number of

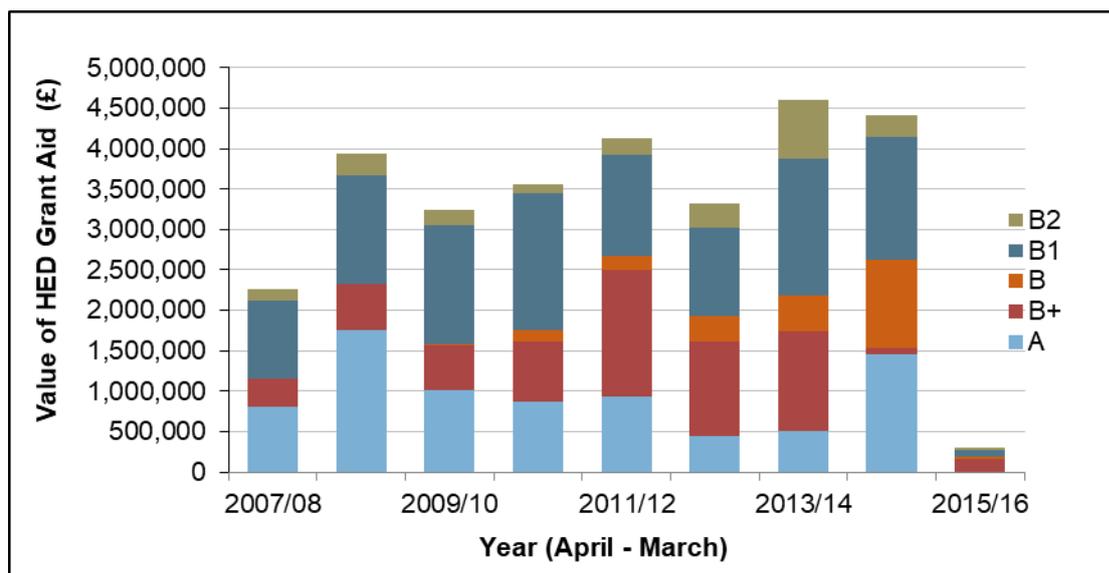
Value of Listed Building Grant Aid by Listed Building Grade.

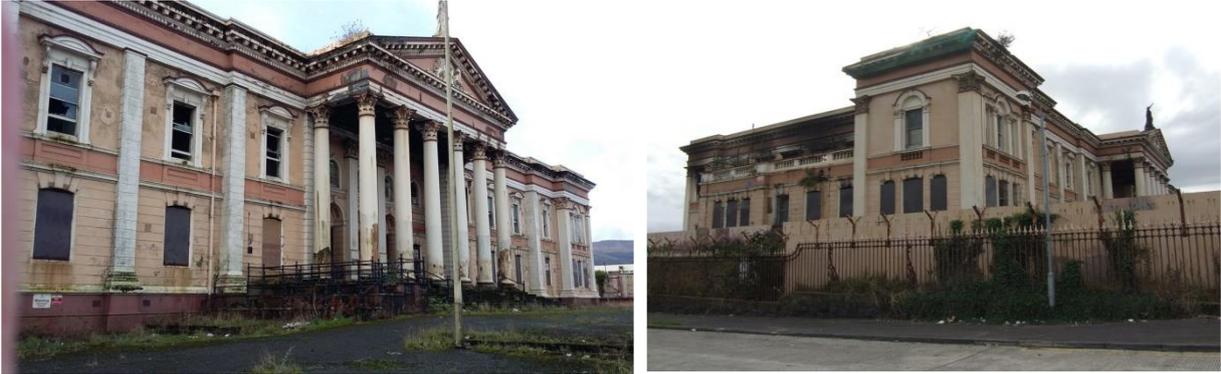
1. CRUMLIN ROAD COURTHOUSE

Location: Crumlin Road, Belfast, Co. Antrim
Status: B+ (Second Surveyed 2009)
HB ref: HB26/35/006
BHARNI ref: 26/35/001

The B+ listed, Crumlin Road Courthouse is a grand neo-Classical building with rendered and brightly painted facades. A large hexastyle Corinthian portico dominates the front elevation and is surmounted by a 'Justice' figure, now lacking the necessary scales. Internally, the central hall and two court rooms *were* considered to be the most important spaces.

Since decommissioning from its original use, the Courthouse, empty since the late 1990s, has suffered a series of arson attacks which have seriously damaged much of its roof structure and important interior. Following a number of transfers in ownership, in March 2016 it was announced that Crumlin Courthouse has recently been purchased and is currently proposed for re-use as a hotel.

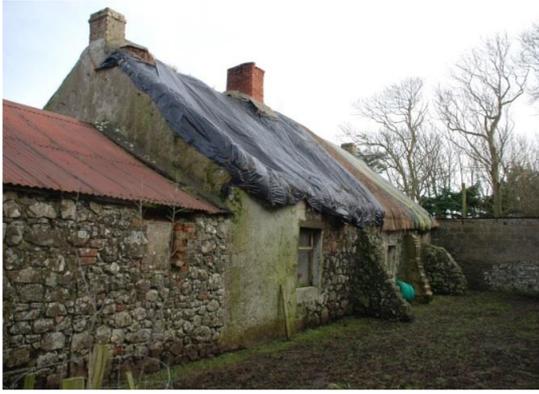
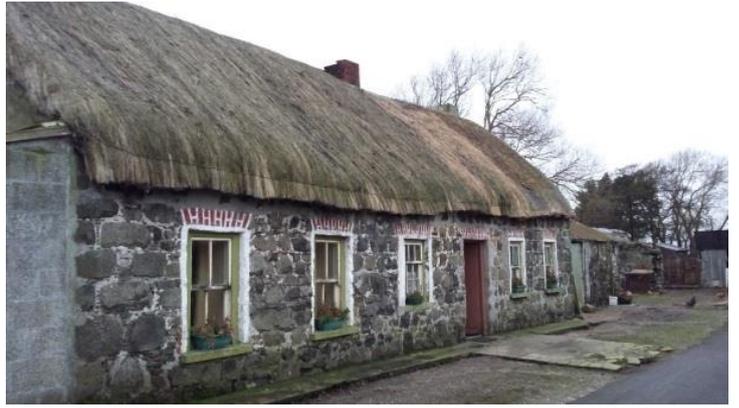
2. THATCH COTTAGE, 360 SEACOAST ROAD

Location: Seacoast Road, Magilligan, Co. Londonderry
Status: B1 (Second Surveyed 1997)
HB ref: HB02/09/045
BHARNI ref: 02/09/003

A B1 listed thatch cottage located in the North-West of Northern Ireland added to the BHARNI register in 2015. The cottage is a six bay long basalt built thatched house with gabled ends, three chimneys and jamb wall entry. The thatch is neatly done in marram grass or bent with the typical fringe eaves finish neatly trimmed and roped. The owner did the thatching himself with bent cut from the M O D lands with permission. Good example of a small late Georgian vernacular thatched house. Part of the roof has collapsed and a structural engineer has deemed the property structurally unsafe and dangerous to live in. It is important that these problems be addressed soon before the property deteriorates any further. Through support from the Department for Communities Historic Environment Fund, the Magilligan Fund and UAH, works are ongoing to repair and restore the cottage.

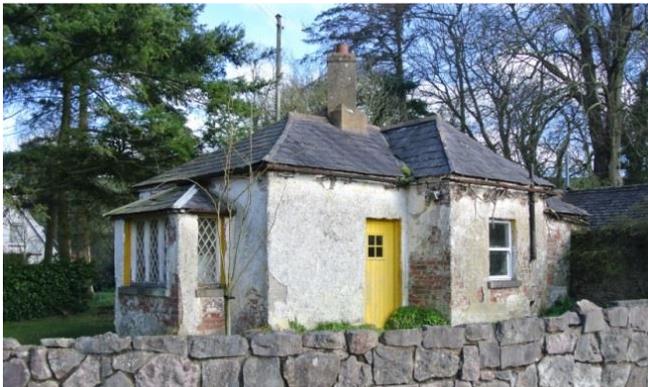
3. GATE LODGE AT HOCKLEY LODGE

Location: Dunmilly Road,
Richhill, Co. Armagh
Status: B1 (not Second Surveyed)
HB ref: HB15/03/009 A
BHARNI ref: 15/03/002

Hockley Lodge added to the BHARNI register in 2003 is considered by Brett to be “An unexpected Regency stucco cottage of the grander kind, perhaps of 1817-20”, further adding that it is “a bit out of place in the lush countryside of County Armagh, though perhaps with affiliations to the lamented Pavilion in the city”. Three gate lodges once graced the various entrances to the main house but, as reported in Buildings at Risk, Vol. 4, p. 33, the Drumilly lodge was demolished in 1996. Fortunately, this little lodge of c.1834, which is arguably the most attractive of the original three, still stands. Described by Dean as “single-storey 3-roomed on a cruciform plan”, it is now somewhat overgrown, as it was when it first appeared in Buildings at Risk, Vol. 4. The condition of the render is slowly deteriorating incurring brick exposure. In parts the rain water goods have failed and are blocked with vegetation. The tiled roofed is in fair condition, however tile slippage in certain areas raises concern for facilitating water ingress into roof structure.

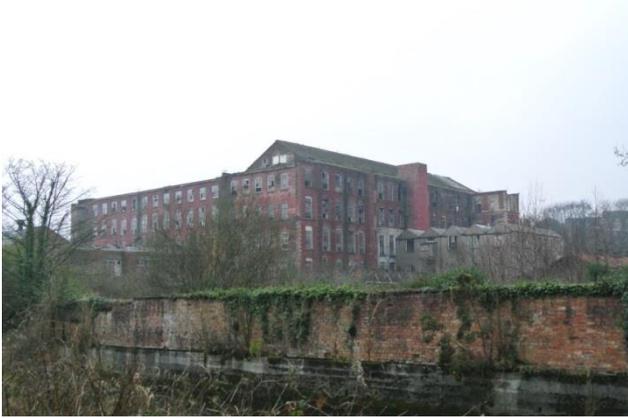
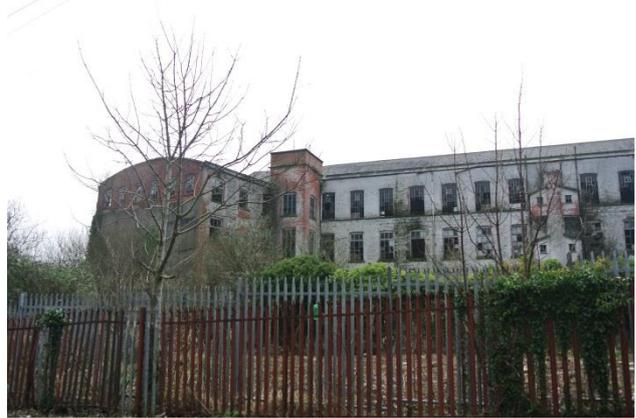
4. BARBOUR CAMPBELL'S THREAD MILL

Location: Mill Road, Hilden, Co. Antrim
Status: B+ (Second Surveyed 2010)
HB ref: HB19/17/013 A
BHARNI ref: 19/17/001

The Barbour Campbell Threads complex at Hilden closed as a manufacturing centre and consequently added to the BHARNI register in 2005. At one time the mill was said by Bassett to have accommodated “the largest manufacturers in the world of tailors’ thread and shoemakers’ thread for hand and machine sewing”. The complex comprises a number of brick, stone and stucco finished buildings with perhaps the most interesting, architecturally, being the five-bay, two-storey counting house. The remaining structures are, for the most part, unadorned but are just as impressive due to the scale and robustness of their construction. As the Mill and ancillary buildings now lie vacant and derelict, the surrounding area has been subject to an ongoing mixed-use redevelopment scheme which plans to reuse parts of the mill building. However as of yet work on the Mill building have not commenced where it is hoped that the listed structure is approached in a sensitive and conservation-led manner, yet in the meantime the building is steadily deteriorating with no remedial care.

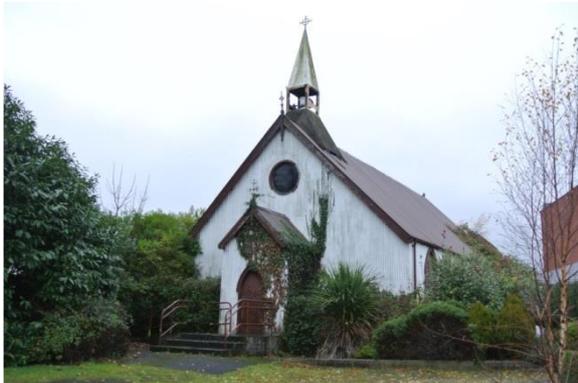
5. ST. MATTHIA'S CHURCH

Location: Glen Road, Belfast, Co. Antrim
Status: B1 (Second Surveyed 2000)
HB ref: HB26/22/003
BHARNI ref: 26/22/001

Although not now uncommon to feature an ecclesiastical building as a building at risk, this particular church is a highly unusual example. Once referred to as the ‘Jesse James Chapel’ it is described in the HM/BR as a “Rare example of a corrugated iron clad single storey church of 1892 in plain Gothic style. Its appearance is of a frontier church of the American west”. Hence the outlaw reference. First opened in 1892 by the Lord Bishop of Down, it was used for some 70 years by the Church of Ireland, before being re-consecrated as a Catholic Church in 1970, following demographic changes in the area. Initially coming to prominence following plans for its replacement with a new church building, it was subsequently listed B1 and has lain empty ever since. It is an extremely rare building of great social importance to the area and it would be hoped that some beneficial use can be found. When reviewed in 2016 the increasing growing ivy on the structure may be a cause for concern as well as weathering of the corrugated iron.

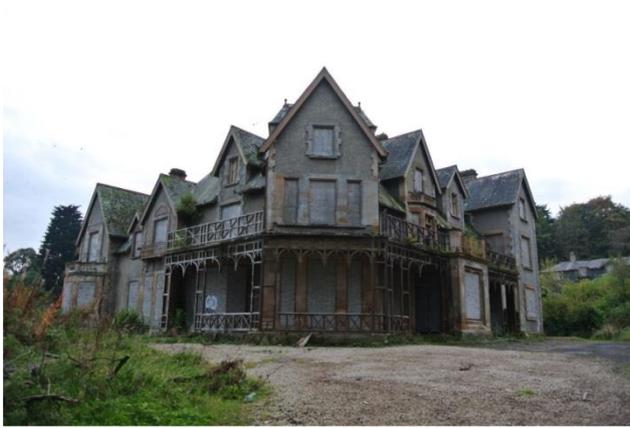
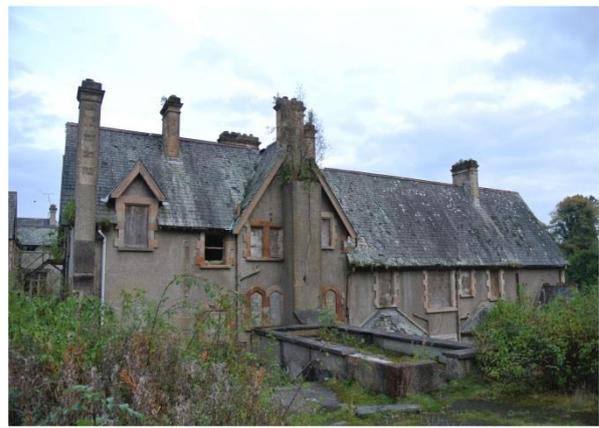
6. CAIRNDHU

Location: Cairndhu, Coast Road, Ballygally, Co.Antrim
Status: B1 (Second Surveyed 1997)
HB ref: HB06/03/008
BHARNI ref: 06/03/001

Built for John Stewart Clark sometime around 1880, and extended by well-known local architect Samuel P. Close in 1897, Cairndhu was used as a private home until 1949, when it was gifted by Sir Thomas Dixon to the people of Northern Ireland for use as a convalescent home. That function ceased in 1986 and the building was unaccountably sold, firstly to the local council, and subsequently to a succession of private owners. The house and associated estate buildings of the former Sir Thomas and Lady Dixon Hospital has been the cause of much public concern since the early 1990s. The one-and-a-half storey gate lodge was the first building within the grounds to be featured as a building at risk, while the multi-gabled main building was highlighted soon after in Buildings at Risk, Vol. 2, p. 11, where it was described as being in need of urgent repair. Both the main house and the stable block to the rear have been the subject of two 'Urgent Works Notices' – the first time that this power was utilised by the DOE (NI). However, despite some work being undertaken the house is again open to the elements and considerable original fabric, including the grand staircase and feature fireplaces have been removed. Follow up on the UWNs has not been evident. A new scheme incorporating a care facility and a housing scheme has received some recent publicity.

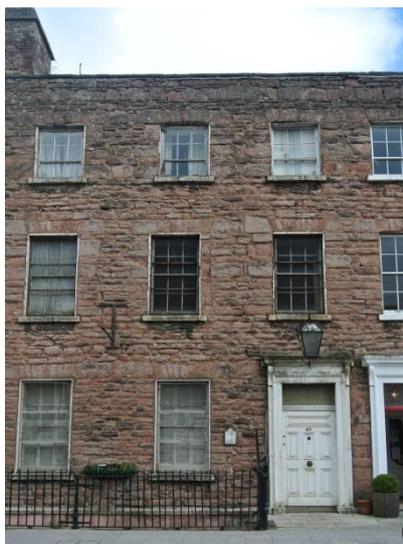
7. NO. 4 SEVEN HOUSES

Location: Upper English Street, Armagh, Co. Armagh
Status: B (Not Second Surveyed)
HB ref: HB15/16/005C
BHARNI ref: 15/16/003

Part of a terrace of six, originally seven, houses erected by Dean Averall (then Rector of Tynan) for occupation by his seven sisters, no. 4 was added to the register in 2017. The handsome three-storey terrace built with Armagh marble limestone with classical detail, were built 1768-1770. No. 4 is suffering greatly from neglect, and most notably the timber frames of the windows are in need of repair, where presently in their deteriorating state will be facilitating water ingress into the surrounding stonework and interiors.

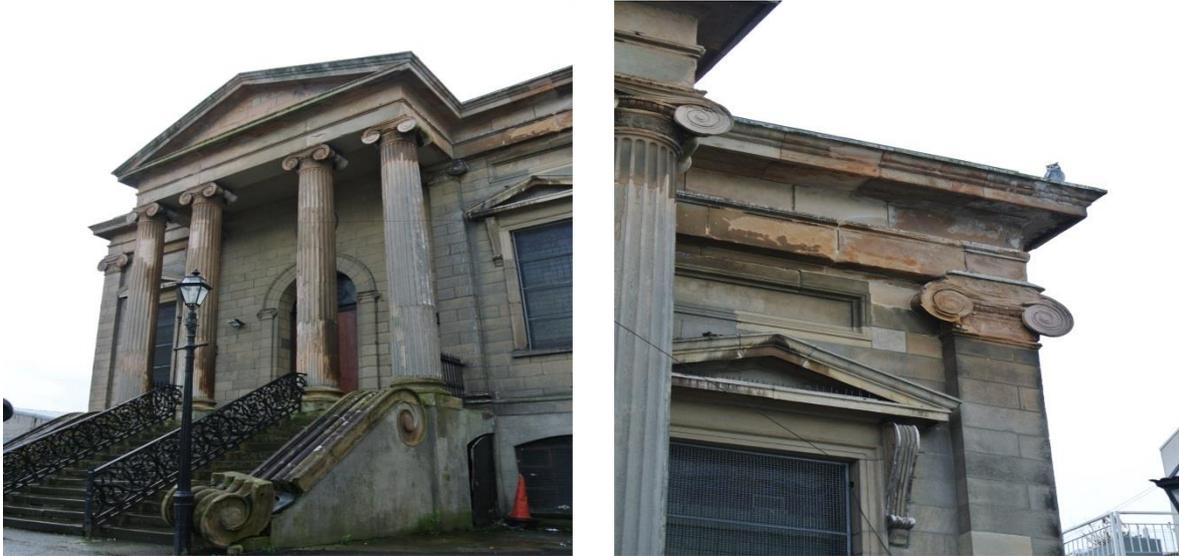
8. GREAT JAMES STREET, PRESBYTERIAN CHURCH

Location: Great James Street, Derry, Co. Londonderry
Status: B+ (Second Surveyed 2014)
HB ref: HB01/21/009
BHARNI ref: 01/21/001

This building has been the subject of much recent speculation. It was first highlighted in *Buildings at Risk*, Vol. 2, p. 69, where it appeared beside the Whitehall Chambers in Hawkin Street. The Chambers have subsequently been demolished and this equally 'difficult' building is now empty and facing an uncertain future. A very powerful neo-classical composition, it was built in 1837 to the designs of Stewart Gordon, and was to be the third Presbyterian Church in the city. Its front façade is dominated by a projecting central-pediment portico supported by four ionic columns on a broad flight of steps, which are flanked by scrolled edges. Behind is a four-bay, two-storey hall with large, round-headed windows. There is a Venetian window on the rear elevation, behind the pulpit. Set back from the main frontage line of the neighbouring buildings on Great James Street, it is certainly an impressive sight, and would be too valuable an asset to lose. The building is currently only used as an ad-hoc venue for temporary music events and the fore ground of the building used as a car-park. It is hoped that interest in this building prevails as although in need of repair, still remains an impressive building on Great James Street. Cultúrlann Uí Chanáin, Irish Language, Culture and Enterprise organisation have recently progressed first stages of grant application and planning, with a view to this building's restoration and reuse.

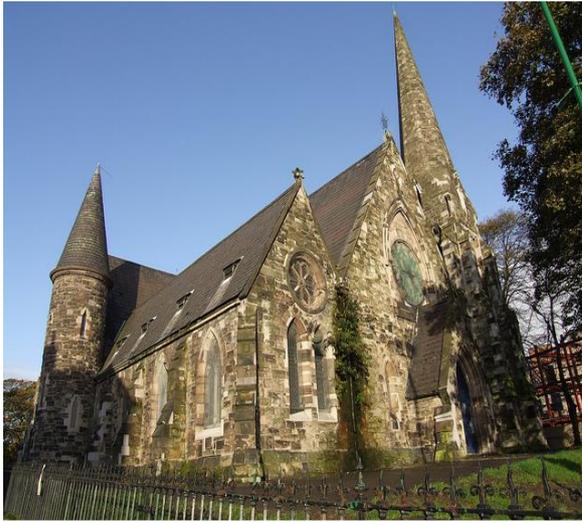
1. DUNCAIRN PRESBYTERIAN CHURCH

Location: Antrim Road, Belfast, Co. Antrim
Status: B+ Listed (not Second surveyed)
HB ref: HB26/43/008
BHARNI ref: 26/43/004
Saved: 2014

The former Duncairn Presbyterian Church, designed c. 1860 by WJ Barre and later developed by architects Young and Mackenzie was a long term building at risk within North Belfast. The building had become redundant in 1995 due to a dwindling congregation and soon purchased by the 174 Trust, who had plans to eventually reuse the church. After a number of difficult years with the building continuing to deteriorate due to water damage and vandalism the 174 Trust managed to secure the funding needed for its restoration.

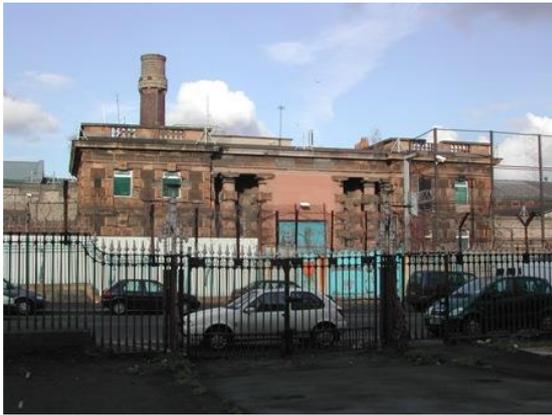
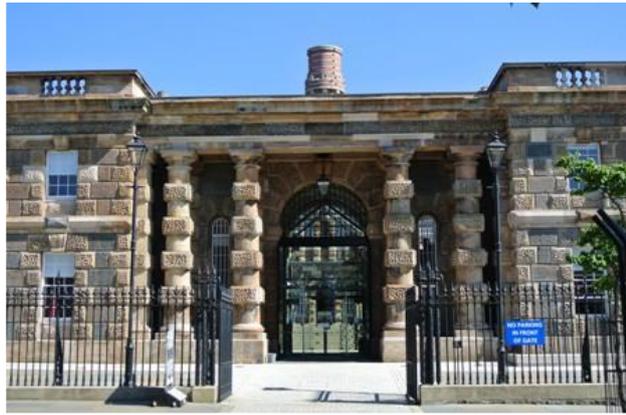
2. CRUMLIN ROAD GAOL

Location: Crumlin Road, Belfast, Co. Antrim
Status: A
HB ref: HB26/43/012
BHARNI ref: 26/43/005
Saved: 2012

A fantastic example of Victorian architecture, Crumlin Road Gaol was designed by Charles Lanyon c. 1845. The gaol is an early example of the 'pentonville radial plan, a significant development in prison architecture at the time'. The prison and facing contemporary courthouse remained in use until they closed in 1996 and faced an uncertain future while proposals for a new use were developed. Both landmark buildings were added to the BHARNI database and featured in BAR Vol. 6, p.30. Unlike the courthouse, the gaol was taken under the wing of OFMDFM and NBCP.

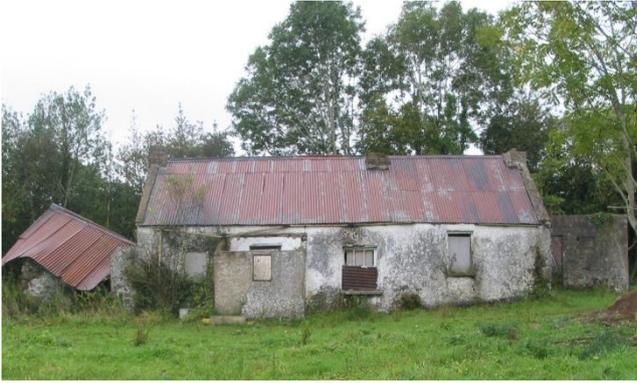
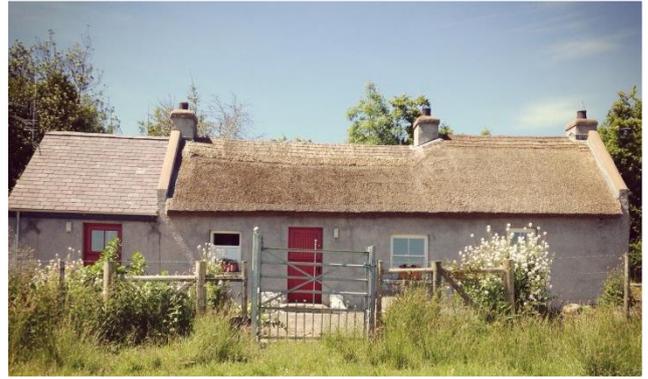
3. GORTINURE ROAD THATCH, MAGHERA

Location: Maghera, Co. Londonderry
Status: B1
HB ref: HB08/01/021
BHARNI ref: 08/01/003
Saved: 2014

A relatively large, single-storey, three-bay, direct entry, vernacular thatched house containing some unusual features. The building is likely to date from the early part of the 18th century.

This building demonstrates the potential for vernacular thatch buildings to be protected and restored without sacrificing modern comforts.

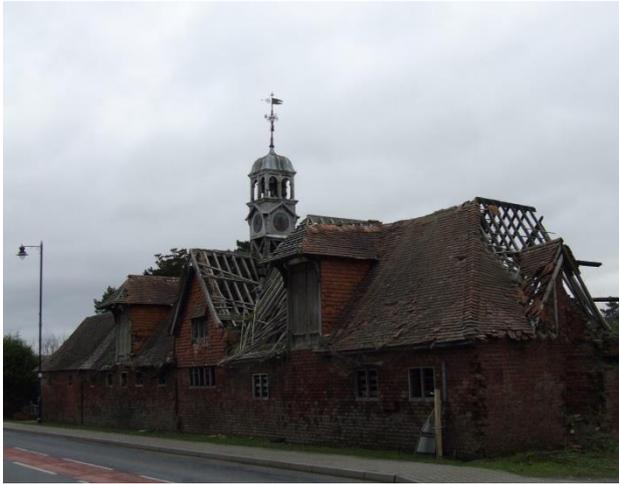
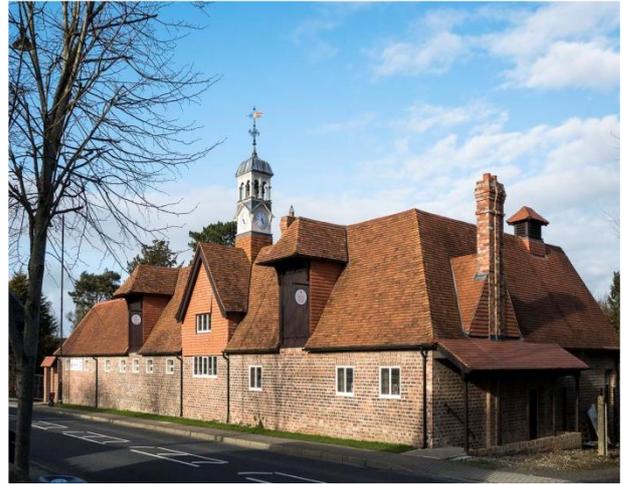
4. STABLES, SION HOUSE

Location: Sion Mills, approx. 5km S of Strabane, Co. Tyrone
Status: B2
HB ref: HB10/07/001
BHARNI ref: 10/07/004
Saved: 2014

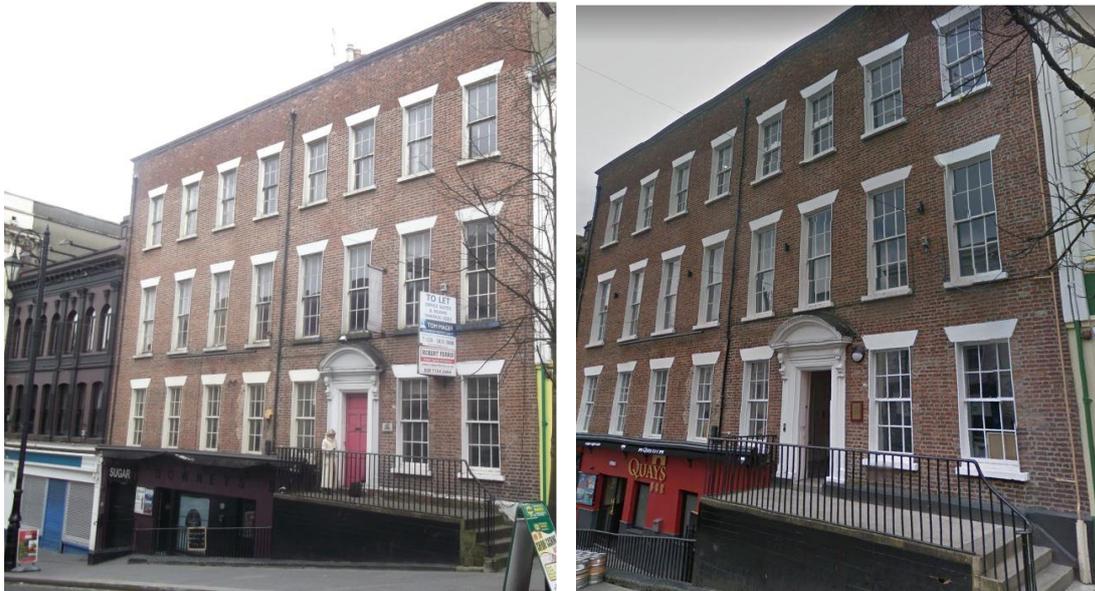
5. 31-33 SHIPQUAY ST, DERRY

Location: Shipquay Street, Derry, Co. Londonderry
Status: B1 Listed in Conservation Area (not Second surveyed)
HB ref: HB01/19/034
BHARNI ref: 01/19/034
Saved: 2015

Dating from 1741, 31-33 Shipquay Street is known to be one of the oldest buildings in the walled city area of Derry. The mid-18th Century building has had a number of uses over the years, notably as a customs house at the end of the 18th Century. The brick faced Georgian façade is understated in nature, increasing from three-storey to four-storey aligning with the steepness of the street. However, the doorcase is a notable feature. The building was described by Alistair Rowan in *The Buildings of Ireland* as the ‘finest remaining 18th Century block in the city... with a fine pedimented doorcase that would not be out of place in Molesworth St or in the Bedford estate in London.’

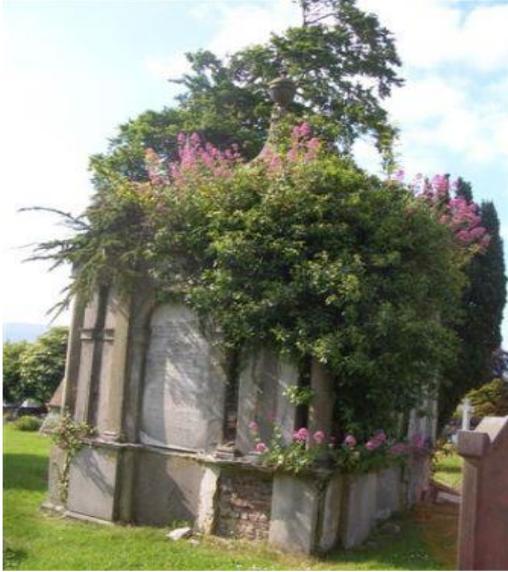
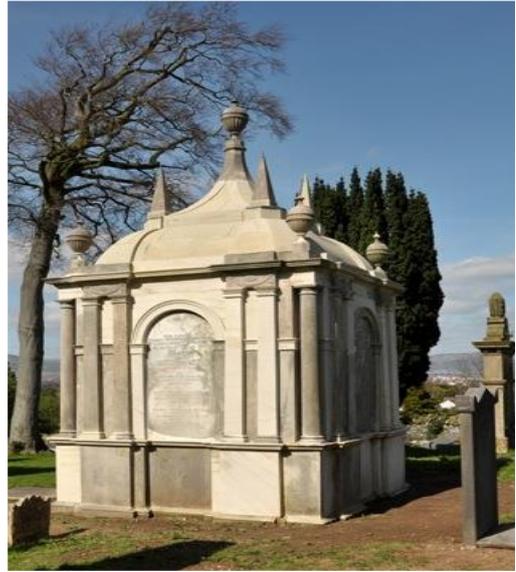
6. KNOCKBREDA MAUSOLEUM

Location: Knockbreda Churchyard, Belfast, Co. Antrim
Status: B+ (Second Surveyed 2011)
HB ref: HB25/16/005 B
BHARNI ref: 25/16/001
Saved: 2011

When it was first formed in 2006 the Follies Trust went through the then BARNI register and decided that the three mausolea at Knockbreda were the most worthy projects to launch us as a building preservation trust. While technically not *follies* we had included mausolea in the categories of small buildings we wanted to conserve. Fund raising was a huge issue as we were new and mausolea are not attractive to many funders but, with the help of the BHARNI Officer, Andrew McClelland, and funding and support from NIEA, now HED we succeeded!

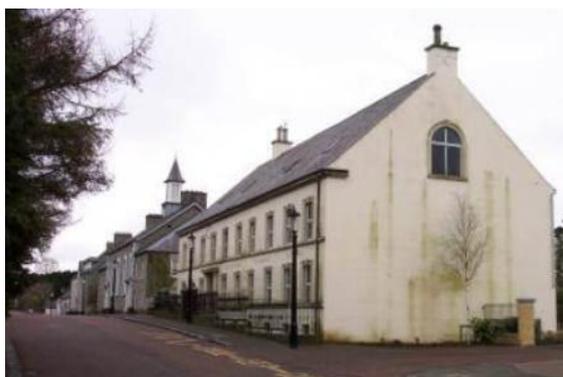
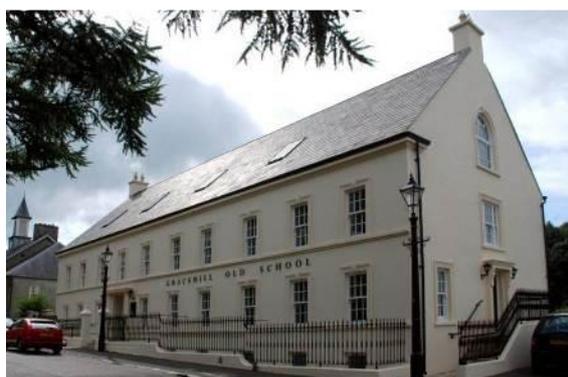
7. GRACEHILL OLD SCHOOL

Location: Church Road, Gracehill, Co. Antrim
Status: B2 (Not Second Surveyed)
HB ref: HB07/15/011
BHARNI ref: 07/15/001
Saved: 2009

Gracehill Old School was on the BHARNI register and was the first building in Northern Ireland to receive an acquisition grant. This innovative pilot funding scheme was subsequently rolled out across Northern Ireland and led to the rescue of a number of buildings at risk.
